Repair of ammonia converter's basket in Abu Qir Fertilizers Company, November 2018

Abu Qir fertilizers Company, Egypt

Haldor Topsoe, Denmark

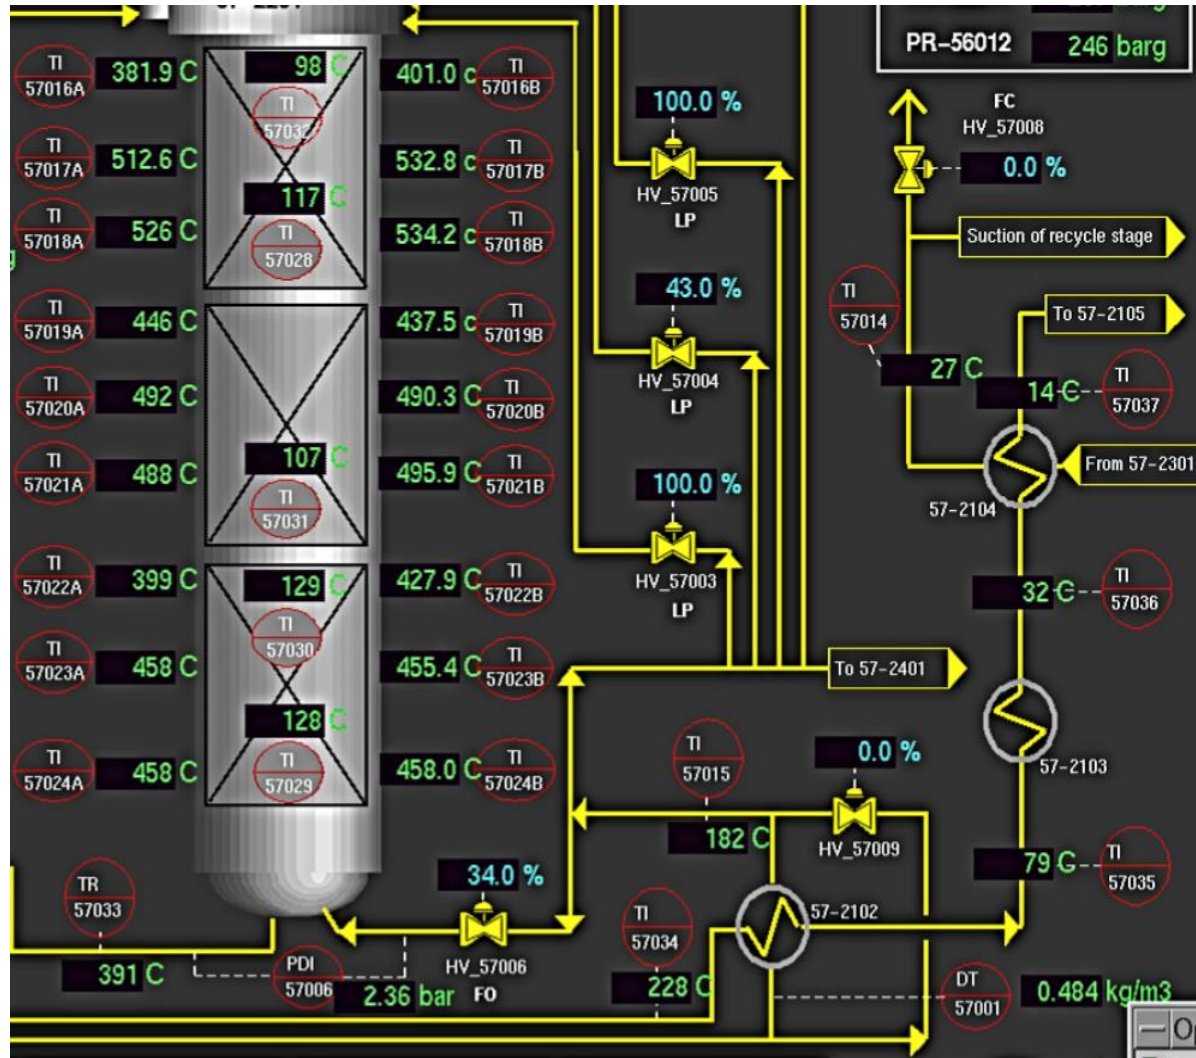
Screenshot from DCS Normal Operation

- When starting up the plant again, a significant abnormal pressure difference showed up reaching 10 bars while it normally measures 2.5 bars in full load condition.

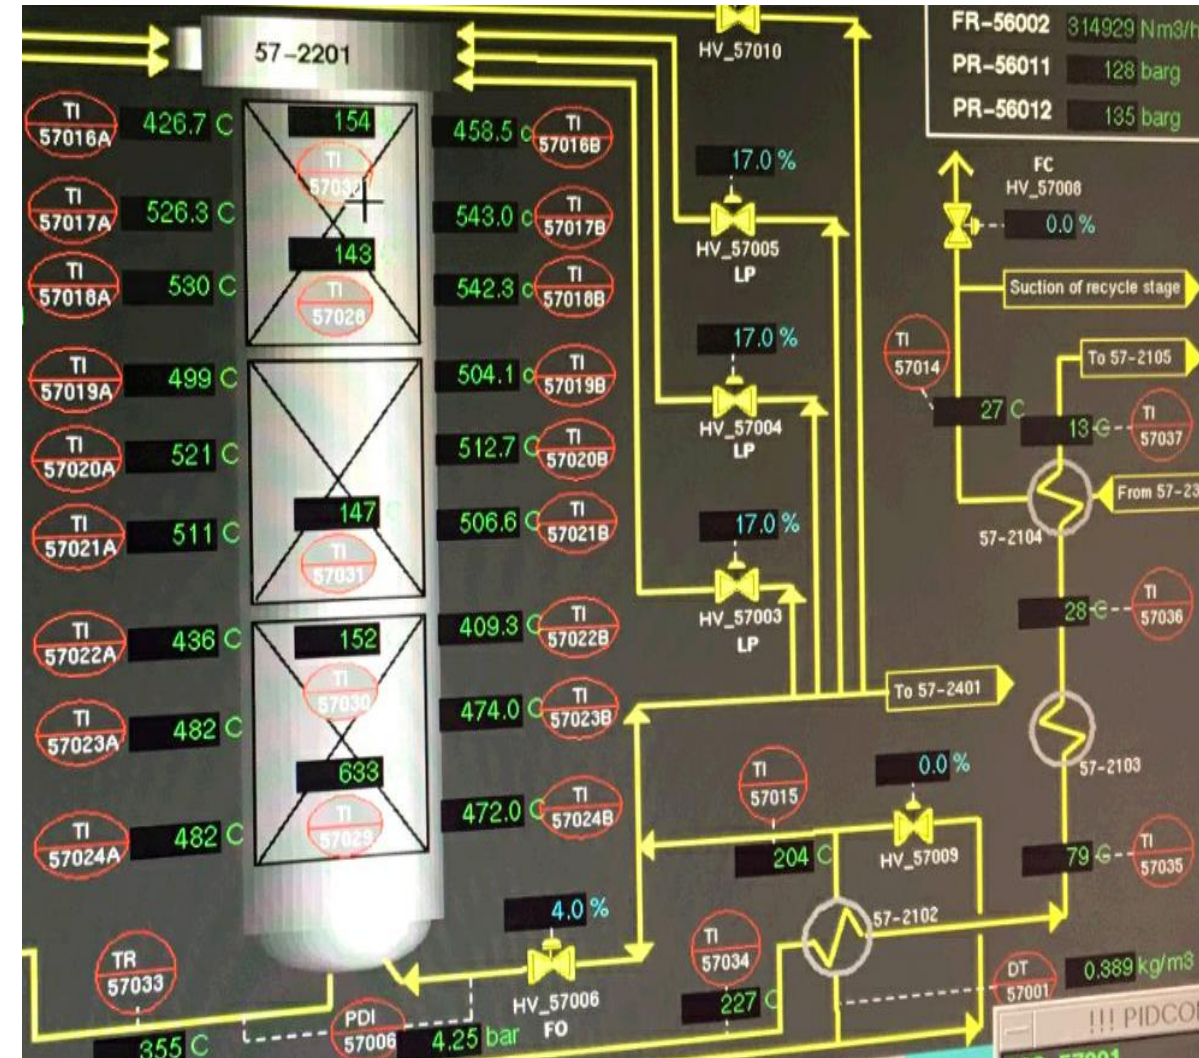
Screenshot from DCS Abnormal condition

- The loop pressure was 120 bar, the anti-surge valves were fully opened so minimum flow was passing through the converter and pressure difference was 4.5 bar, any attempt to load the reactor would lead to increase the pressure difference and then the flow rates to the converter had to be reduced again.

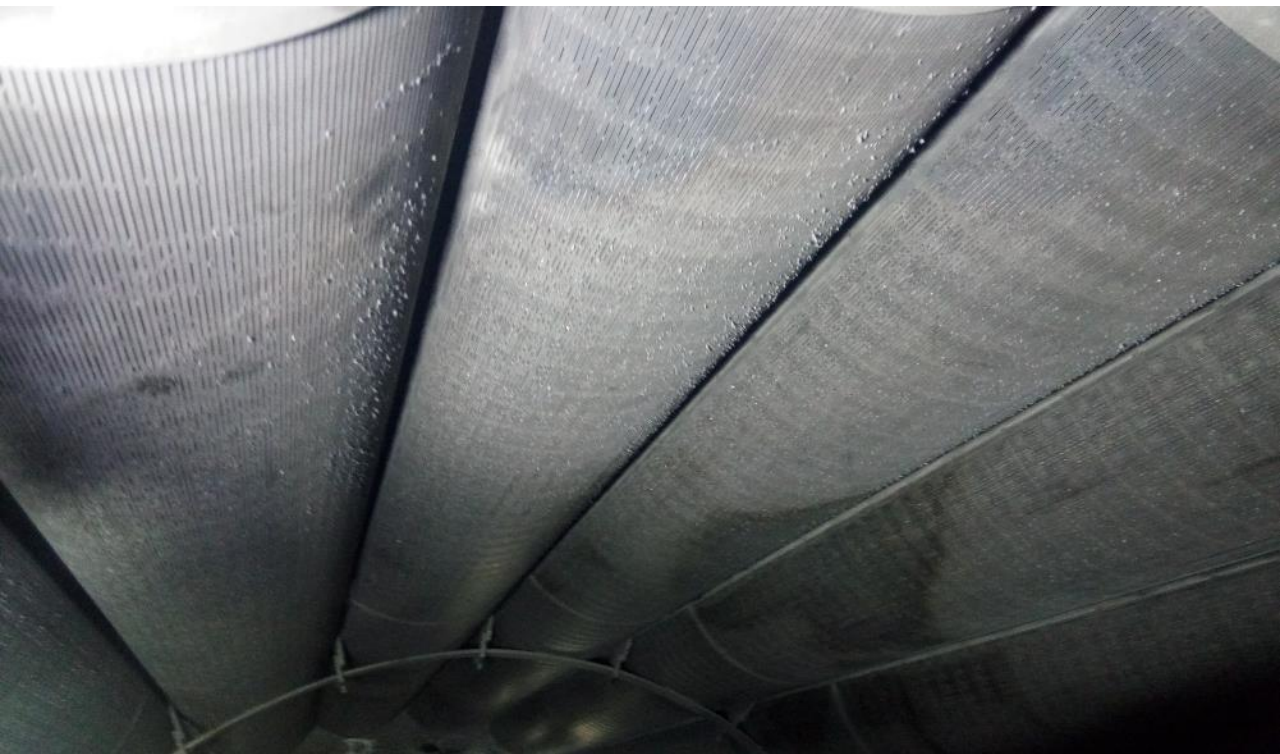
- When inspecting the first bed, the center and outer screens were found in good condition and no mechanical failures or ruptures were found.

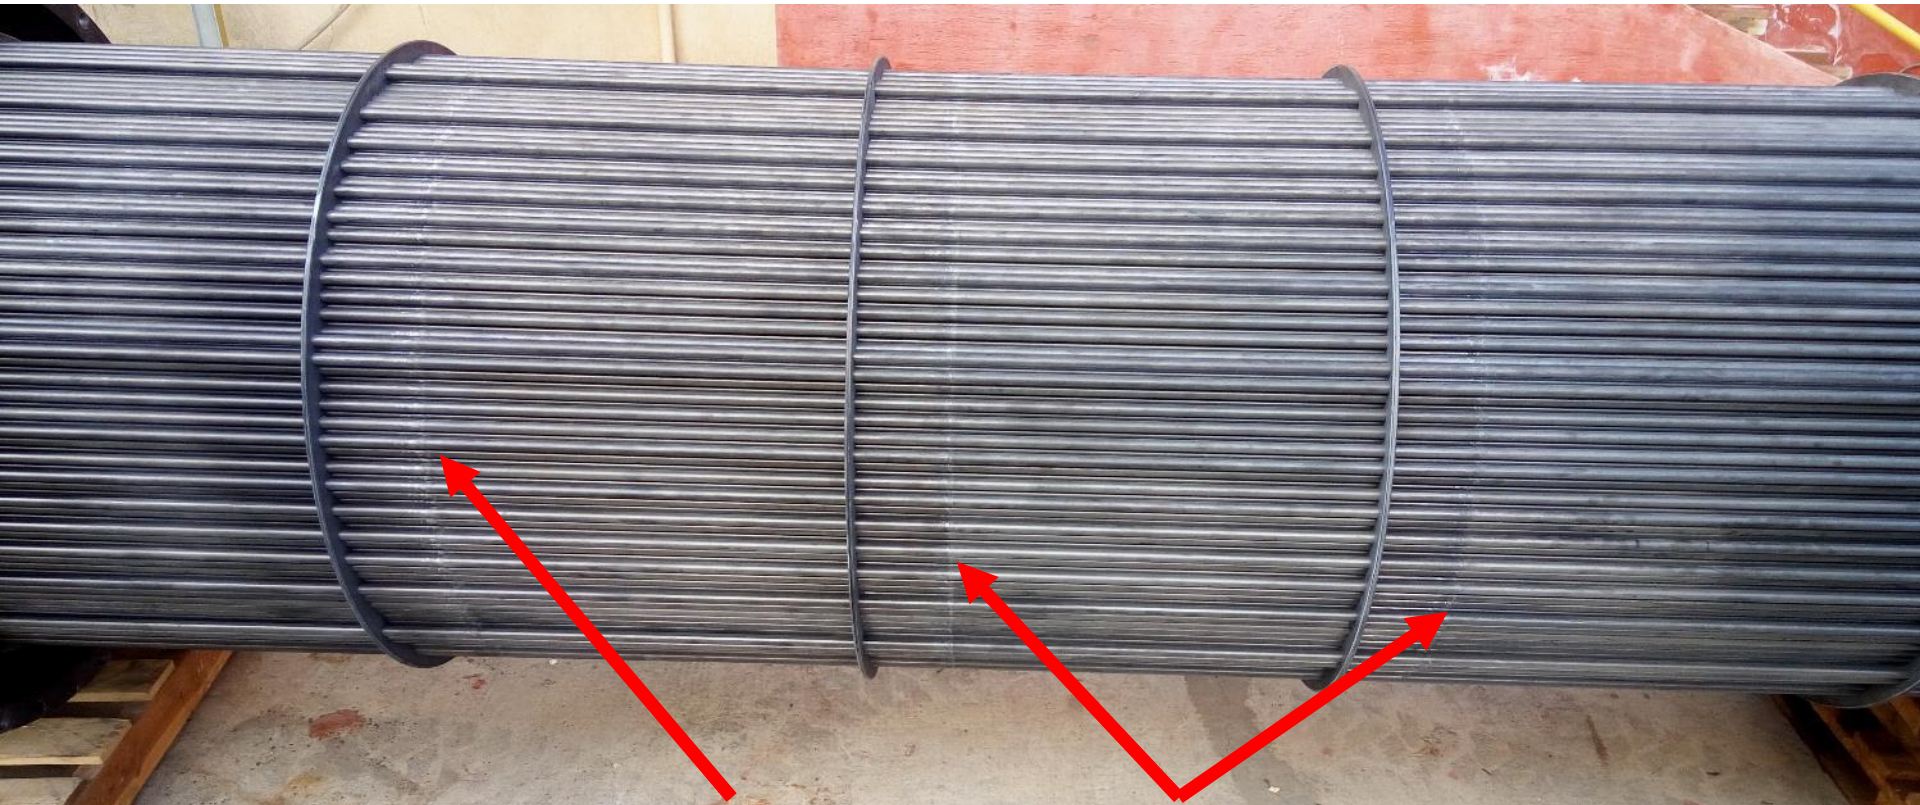
- The intermediate upper heat exchanger was inspected, the baffles were found displaced by 100 mm towards lower direction, all baffles' tie rods were broken and the baffles were stuck at the new position and could not be repositioned.

BAFFLES' ORIGINAL POSITION

10CM

- For The upper heat exchanger, new tie rods were welded to fix the baffles at the new positions.
- A simulation was carried out by Haldor Topsoe and the CFD study concluded that there will be no remarkable effect on the exchanger's performance.

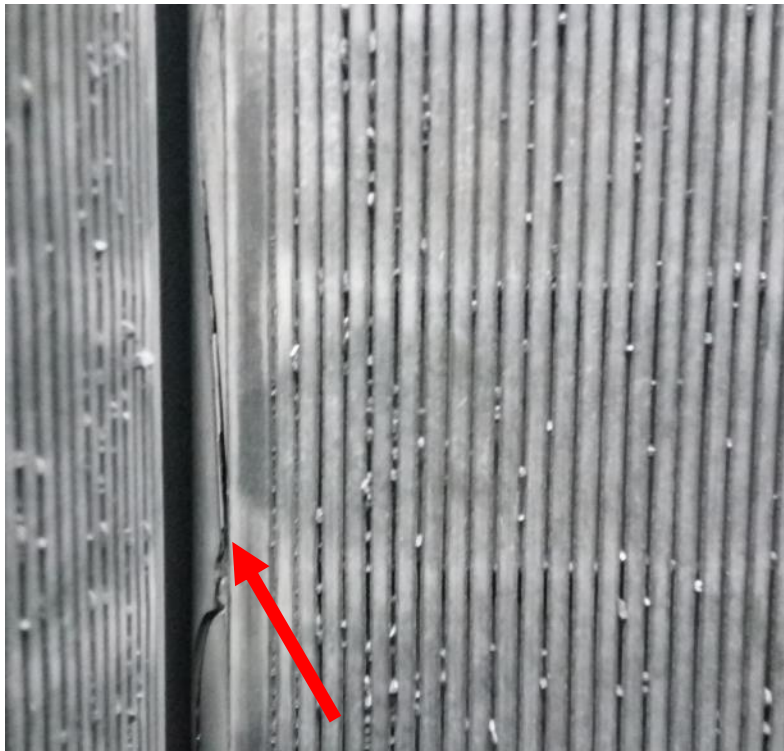
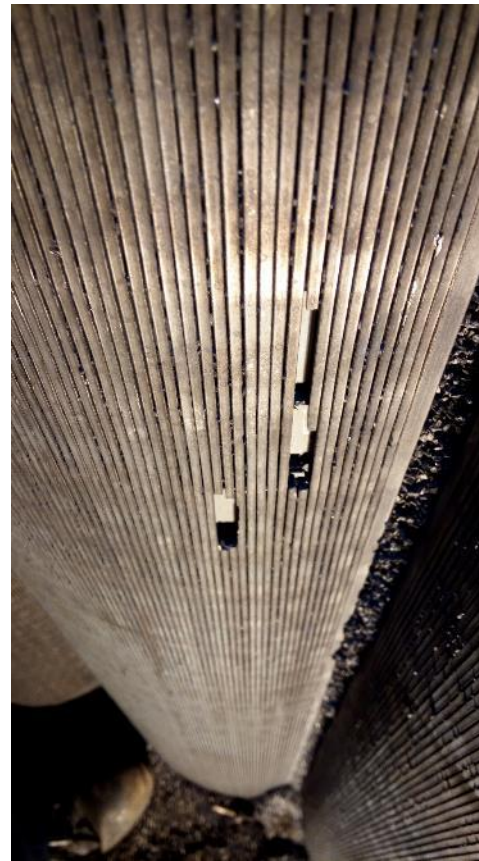
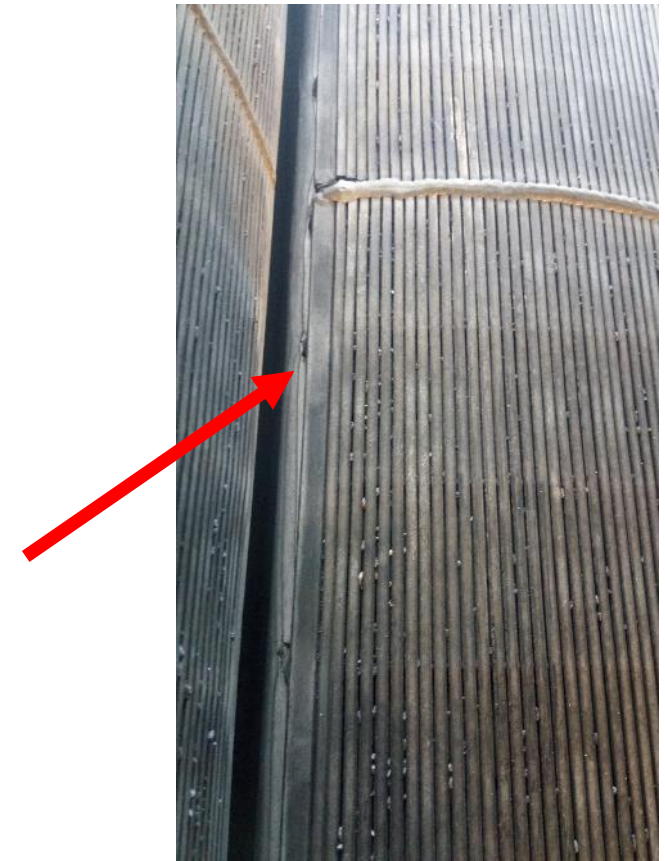
- The second bed's catalyst was unloaded.
- By inspecting, the center screen was found in good condition, some cracks were found in the outer screen due to long time operation at elevated temperatures but no major mechanical failures or rupture were found. Still the main problem cause was not reached.

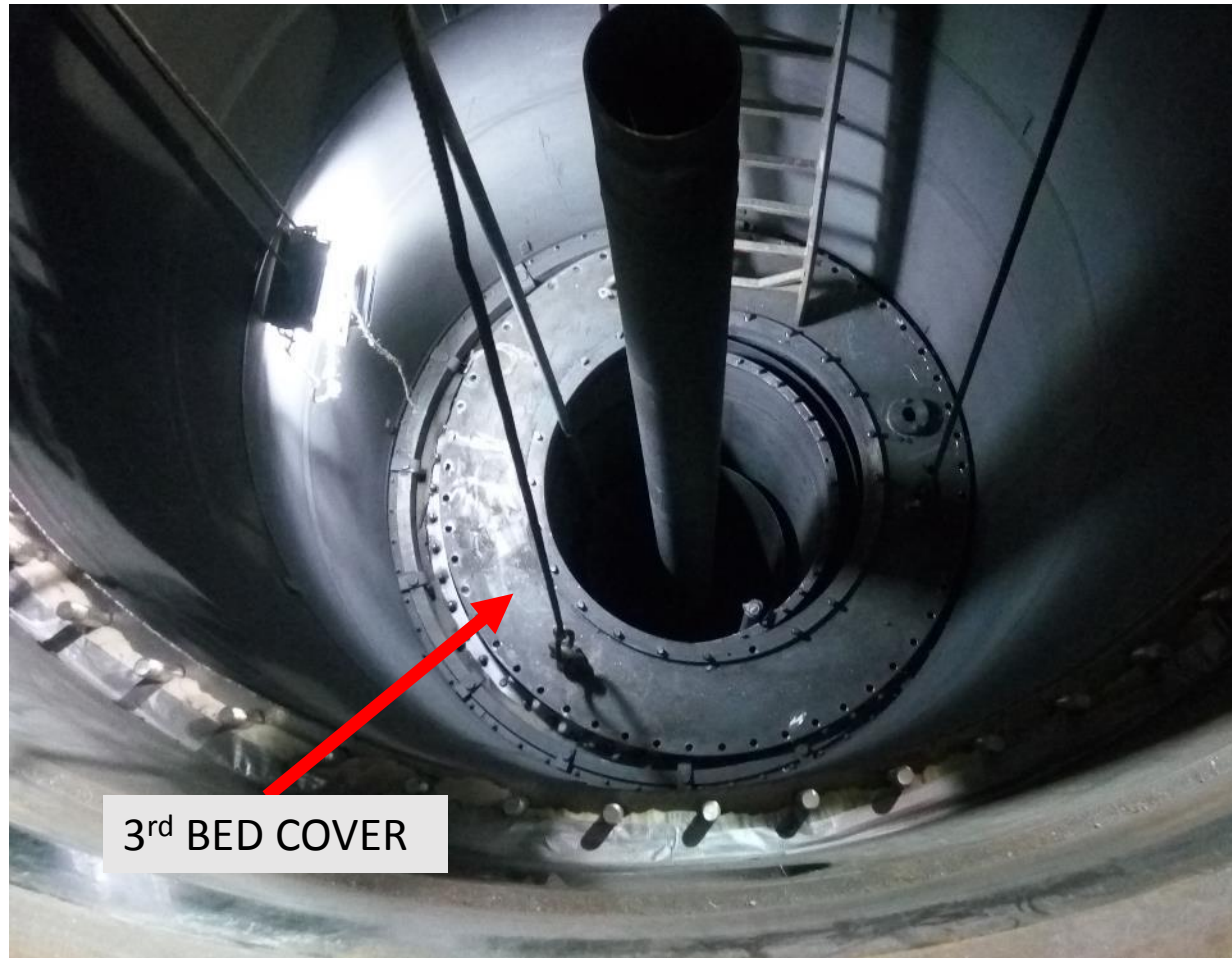
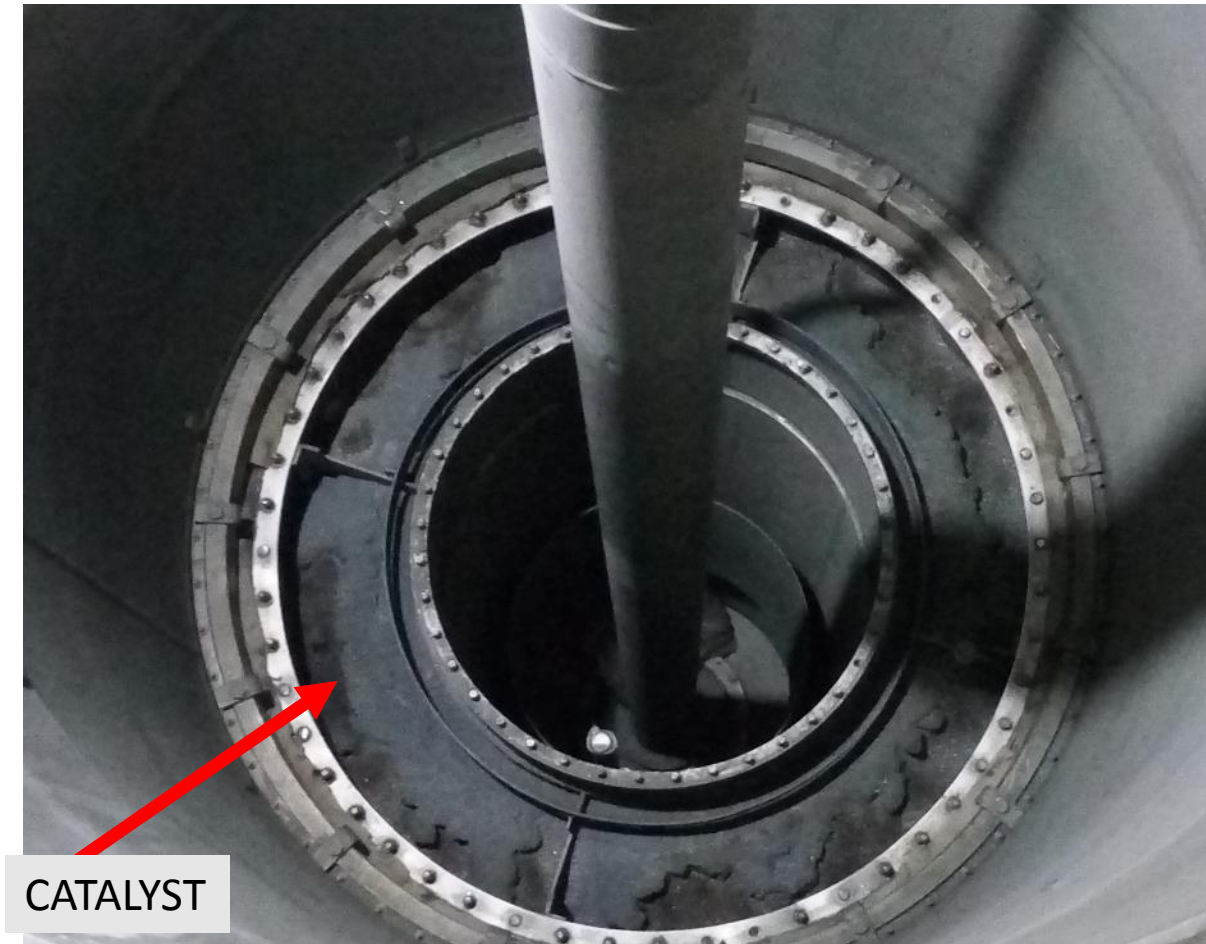
- The third bed top cover was dismantled and the catalyst was unloaded, sintering was more spread in this bed.

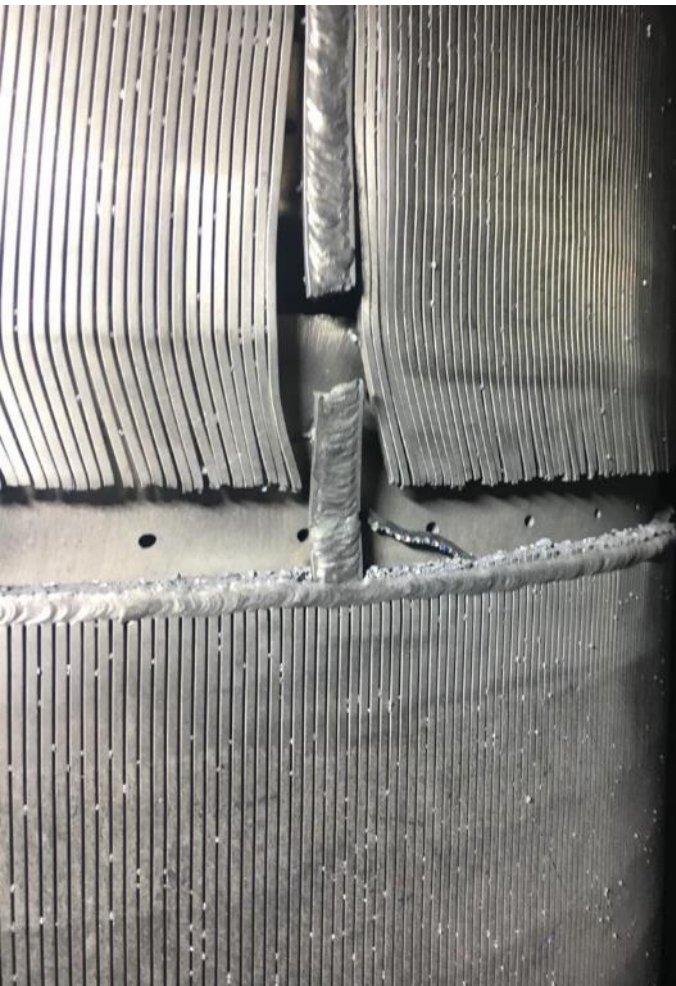
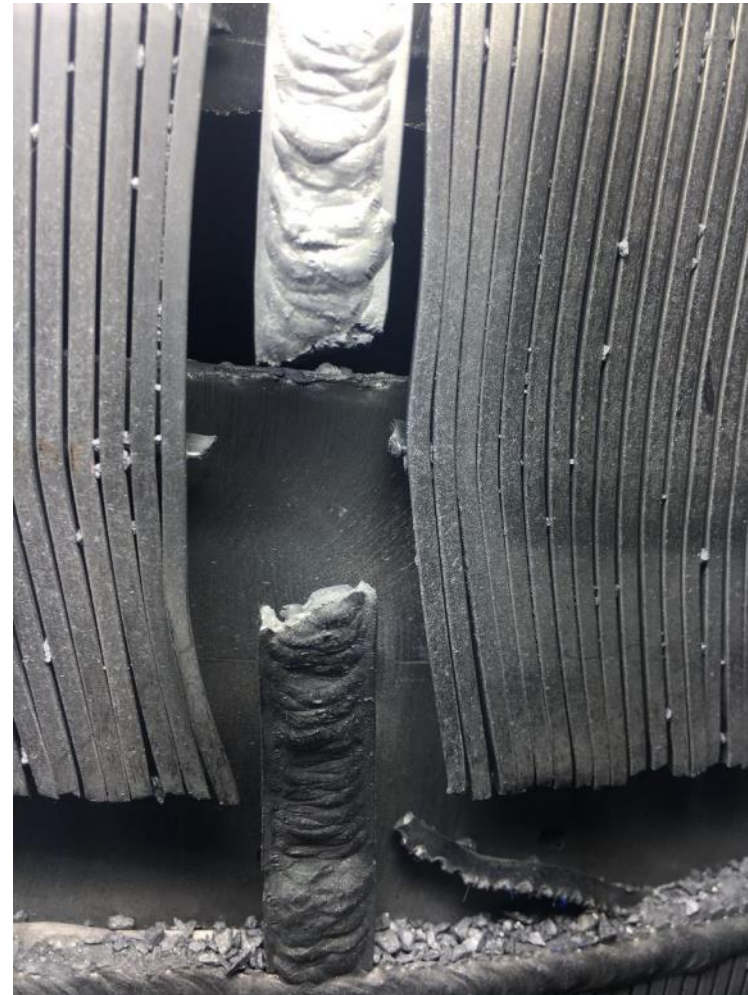
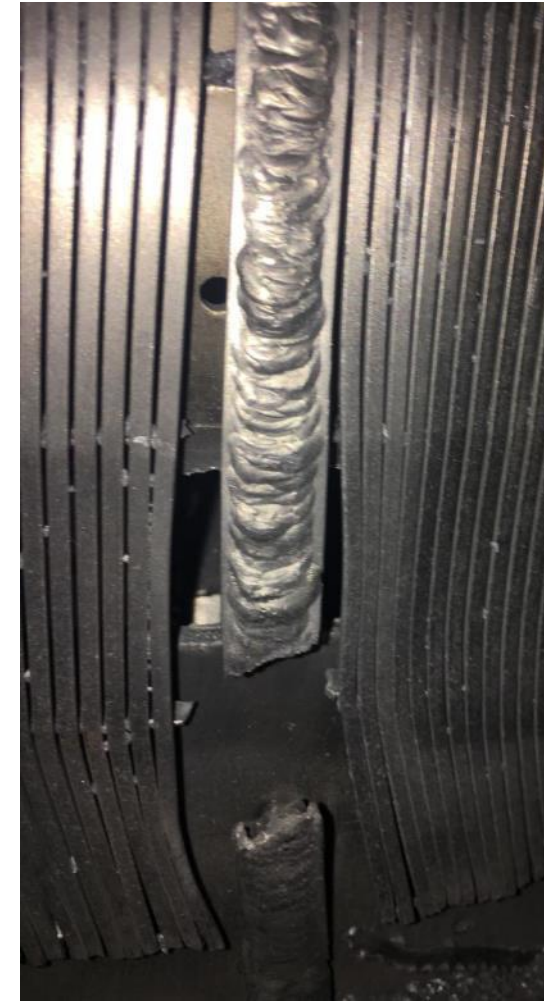
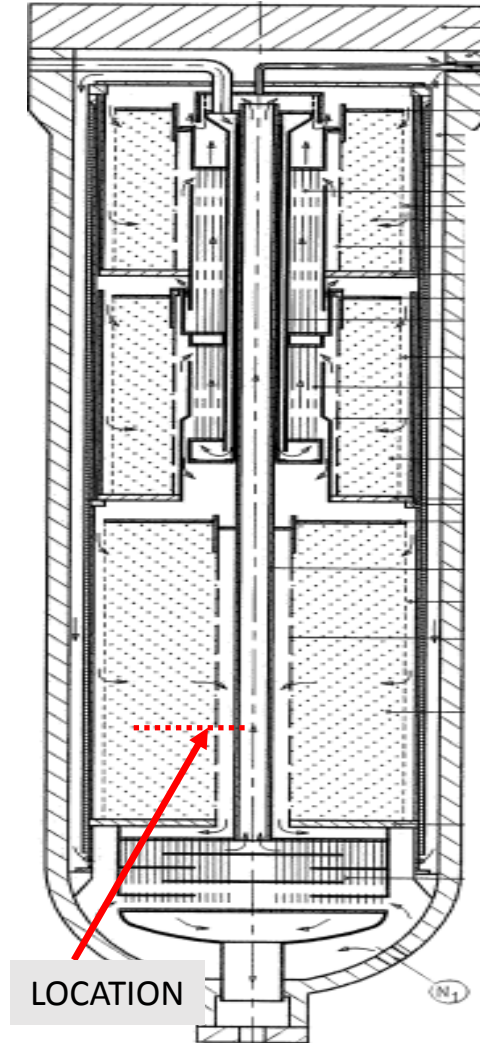
- By inspecting the center screen, a rupture was found at approximately 1.8 meter from bottom.

- After long operating period under high pressure and temperature, the center screen material faced nitriding which increased the hardness of the surface making it more prone to surface cracks.
- Due to the extensive number of startups/shutdowns, the center screen have been exposed to many cycles of thermal and mechanical stresses, progressively weakened and fatigued the material.
- The center screen was exposed to a high mechanical load, during the sudden plant stoppage as caused by the power failure.
- The rupture of the fatigued material was caused by a combination of the above factors and ultimately by the power failure that the plant suffered from.

- The second point is to repair the failed area of the center screen.
- The repair at rupture was to cut away a band of 250 mm of damaged screen wire and weld reinforcement bars of the same length filling the clearance and finally welding a ring of 500 mm diameter with proper overlap with intact screen wire to seal and support the failure area.

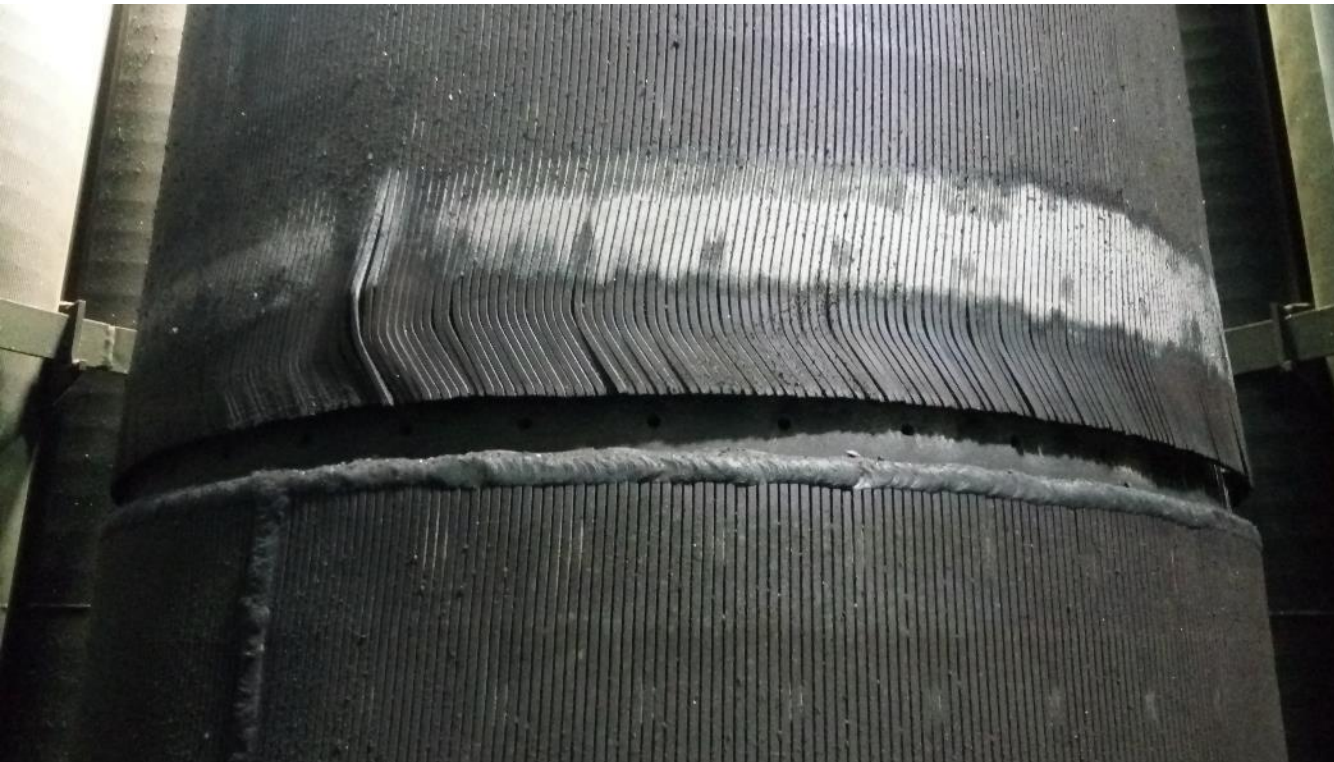
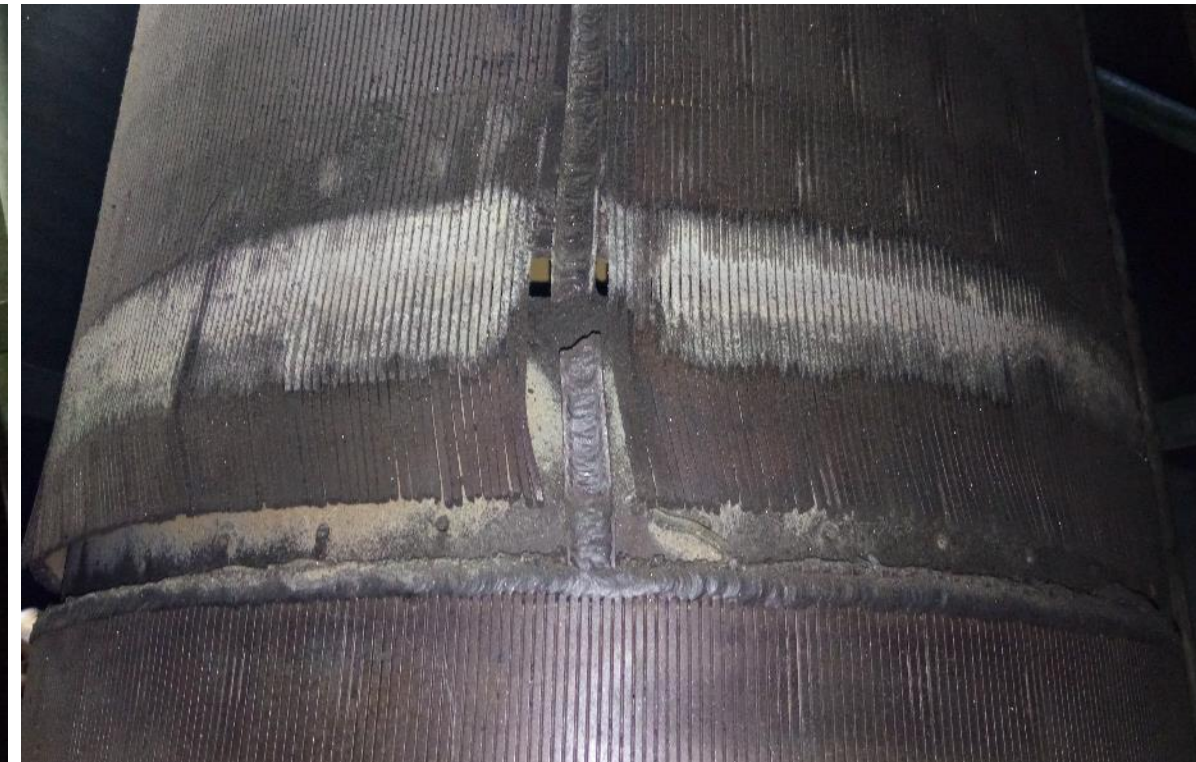
- The failure happened in a welding between the center screen's segments, nearly half of the circumference was crack opened of 5 cm.

- The basket has been subjected to an extensive number of shutdowns and startups. Every time the center screen is exposed to a thermal and mechanical stress. When this stress is applied repeatedly, then small, localized structural damages will occur in the material and the material will progressively weaken due to fatigue. The nominal maximum stress that can cause a rupture on weakened material are much less than the tensile and yield strength of the material. Thereby microscopic cracks will begin to form at the stress concentrators such as near weldings.
- Eventually a crack will reach a critical size, the crack will propagate suddenly, and the structure will fracture.

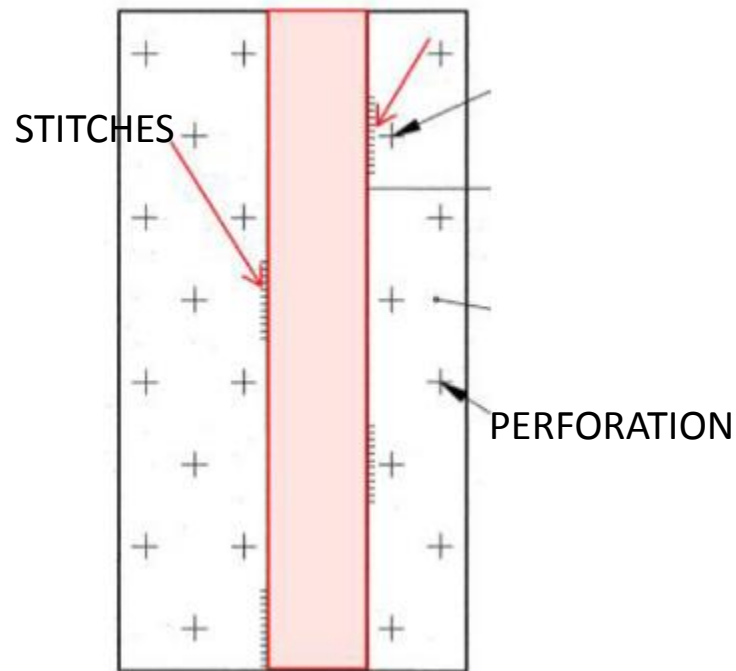
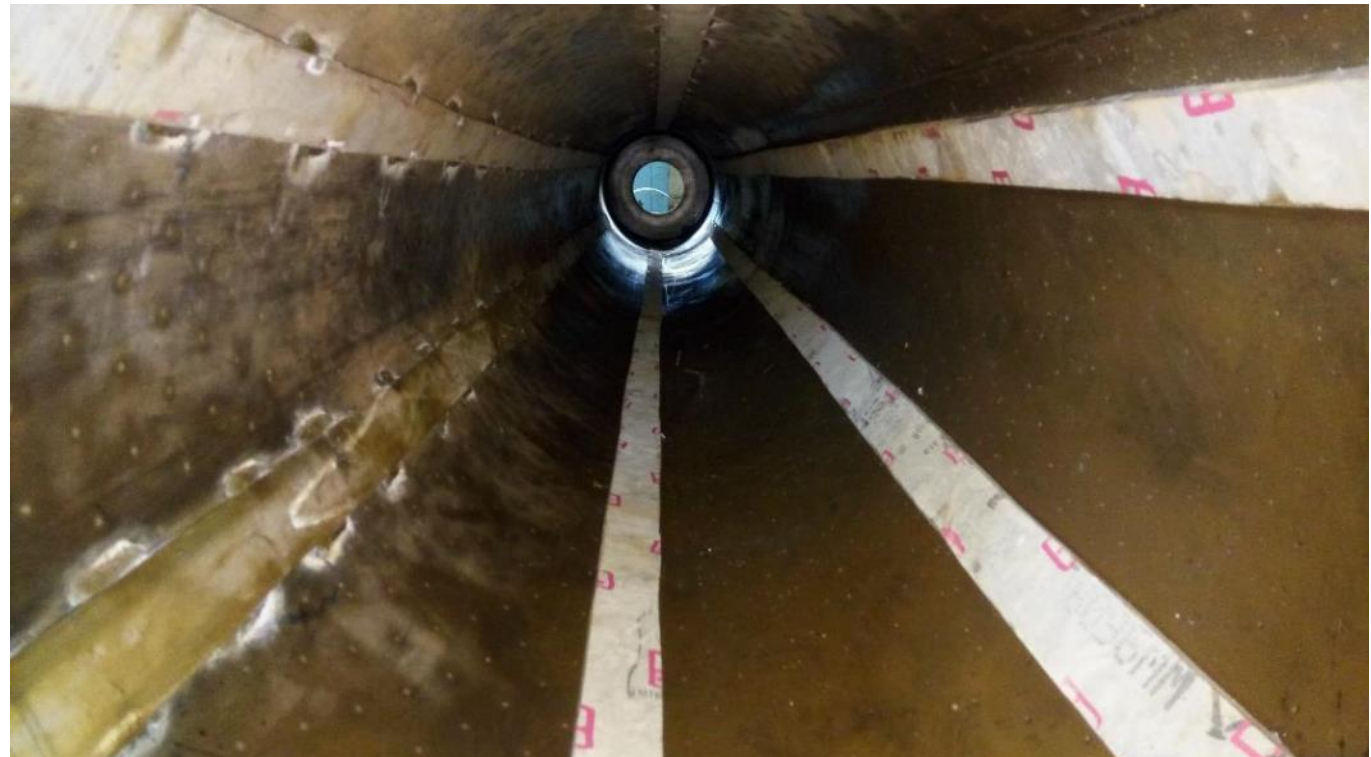
- The center screen consists perforated pipe and screen wire with a clearance of 6 mm between them, with material of construction of Alloy 600.
- The repair procedures sent by Haldor Topsoe contained two main points, first to stitch weld longitudinal reinforcement bars inside the center screen distributed around the circumference with full length to prevent the same rupture to occur again at a different position

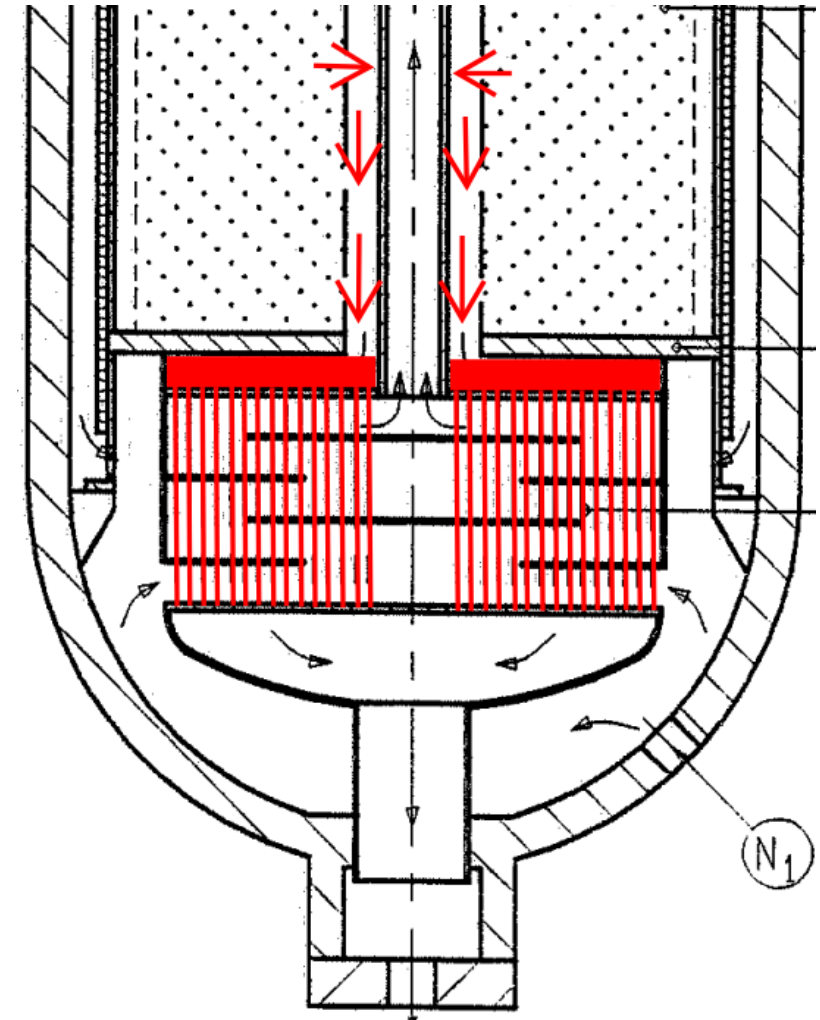
- When the center screen was removed, it was found that catalyst escaped from the center screen rupture and trapped in the chamber between the basket's bottom and the lower heat exchanger's tube sheet.
- The escaped catalyst was sintered and the tube sheet appeared affected and blocked by the migrated catalyst.
- Since there was no access to that heat exchanger below the basket, it was decided to lift up the basket out of the vessel to inspect and clean the tube sheet and also to remove the remaining trapped catalyst.

- When trying to re-operate the plant, the catalyst escaped gradually from the gap in center screen of 3rd bed till it was trapped in the chamber between the basket bottom support plate and the heat exchanger tube sheet.
- The failure of the lower heat exchanger is a follower effect of the ruptured center screen. The cause of the damage is the thermal shock from the excessive heat released by the trapped catalyst.
- The trapped catalyst and plugging of the tubes of the lower heat exchanger resulted in the high pressure difference.

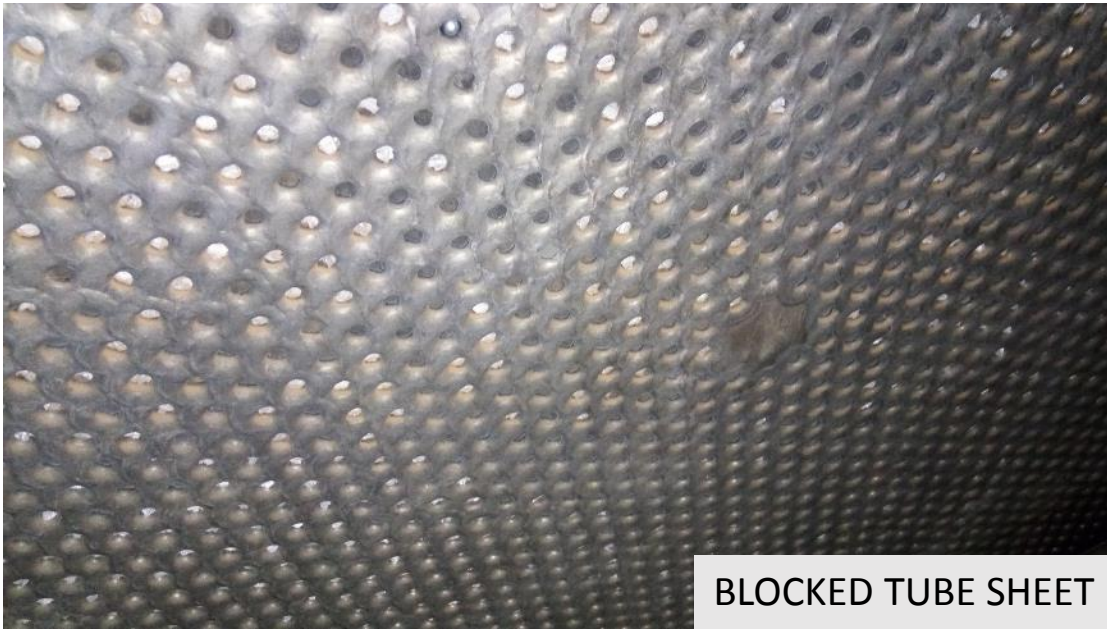
- The lower heat exchanger was cut out and inspected.
- All exchanger tubes were filled and plugged with catalyst. The upper tube sheet was damaged and fused on 90% of its area as well as 90% of tube to tube sheet weldings.
- It was also noticed that many tubes were ruptured enabling catalyst to enter the shell side.

BLOCKED TUBE SHEET

CATALYST IN SHELL

- Abu Qir had to either purchase a new heat exchanger from Haldor Topsoe's subsuppliers or manufacture a new one in local companies or workshops.
- Haldor Topsoe's subsupplier informed Abu Qir that the typical manufacturing time for a new exchanger would take approximately two months excluding the shipment.
- The local manufacturing choice was the time efficient solution.
- A national company located in Suez had the qualifications needed to manufacture a new equipment.
- A team from Abu Qir fertilizers and Haldor topsoe moved to Suez to carry out the process.
- By working in three shifts and by intense supervision, the manufacturing process consumed only two weeks which is considerably a huge time saving comparing to the alternate option.

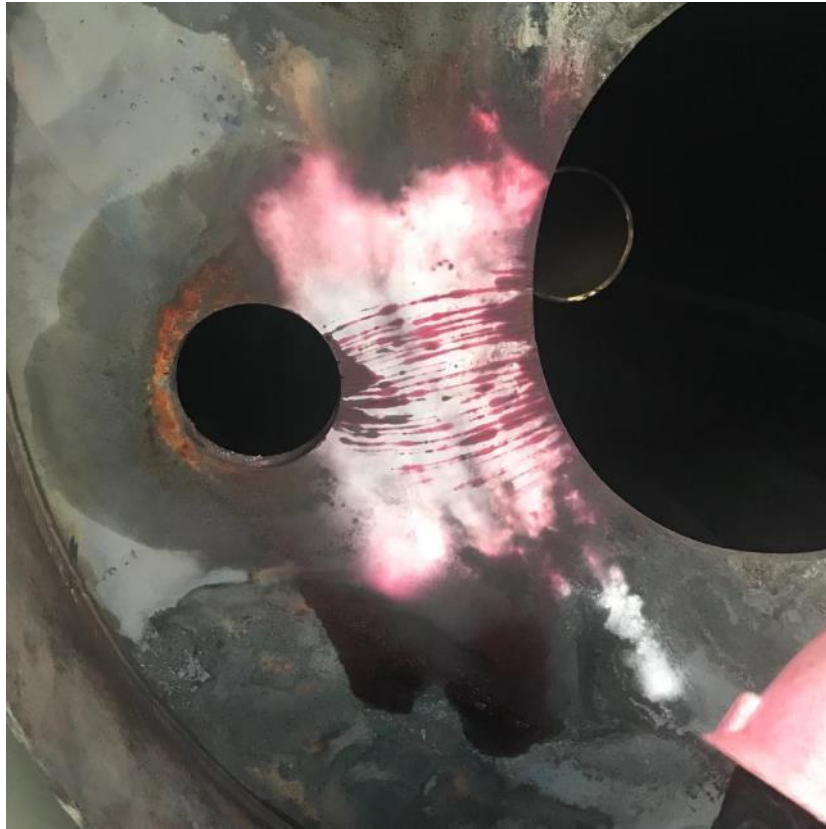
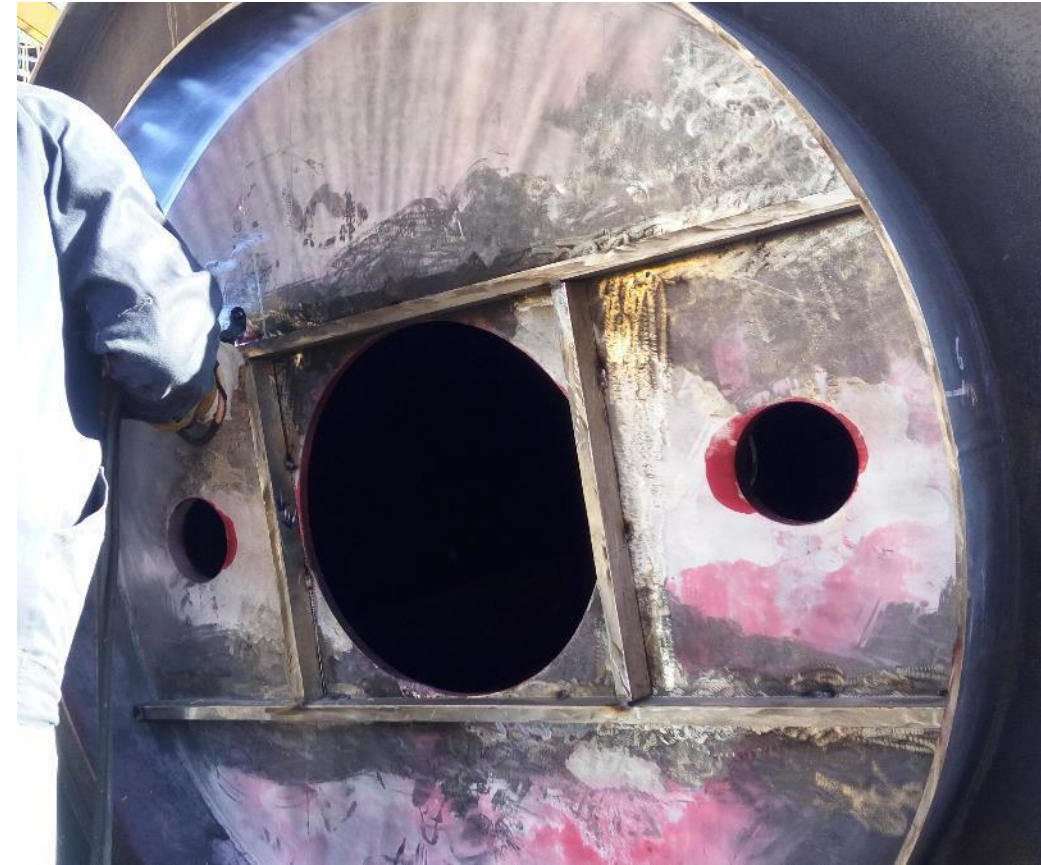
- The basket was inspected thoroughly, hair cracks were found at bottom end.
- The cracks were grinded off, reinforcements were welded at the bottom of the basket to support it against the catalyst weight above it, all bolts were replaced by new set.

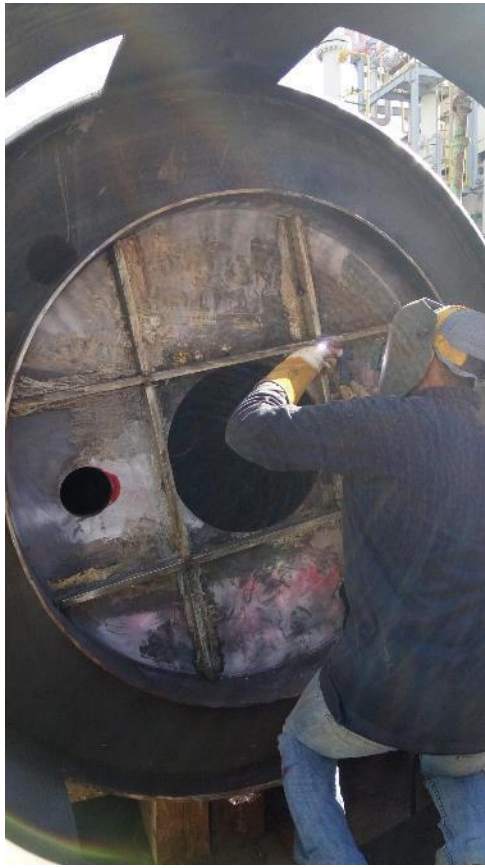
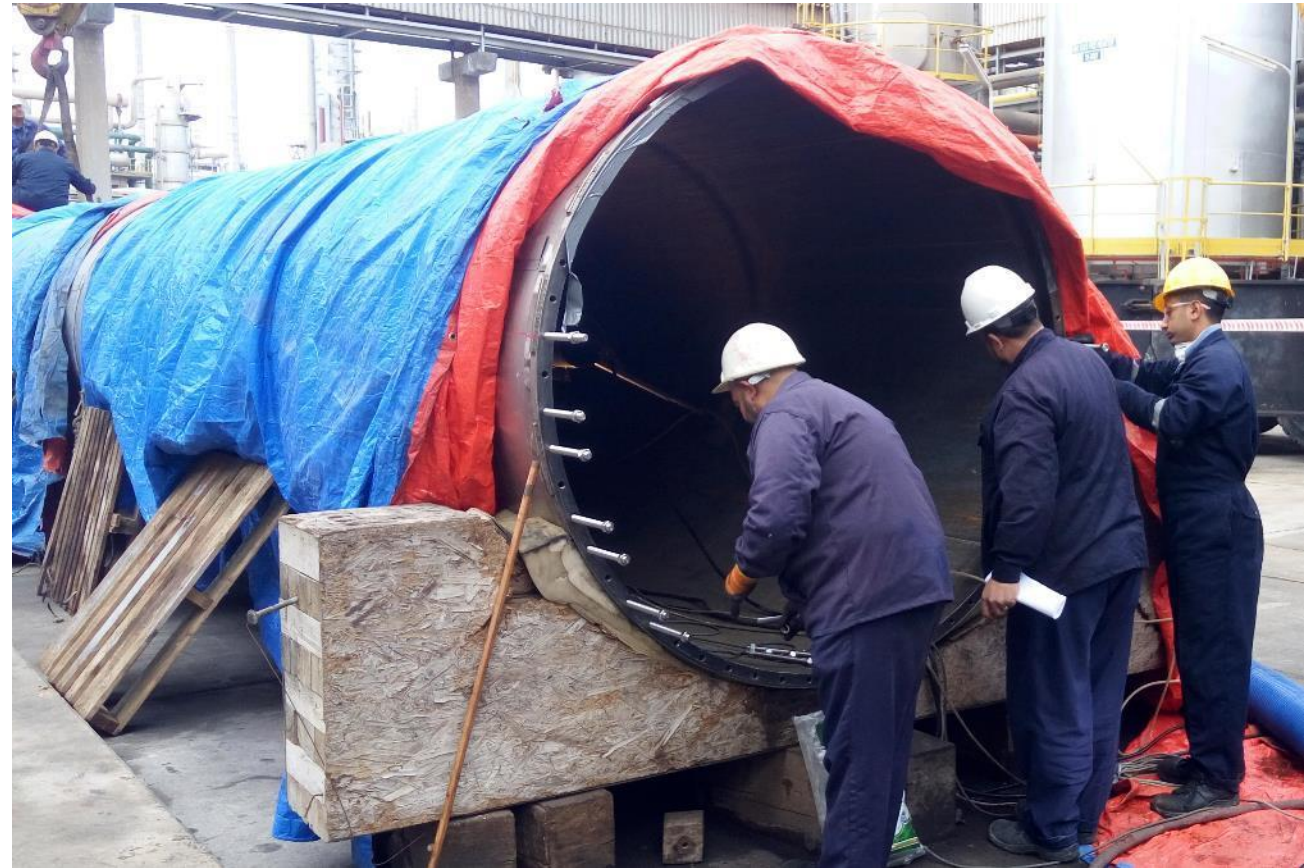
- The basket was inspected thoroughly, hair cracks were found at bottom end.
- The cracks were grinded off, reinforcements were welded at the bottom of the basket to support it against the catalyst weight above it, all bolts were replaced by new set.
