Repair of ammonia converter's basket in Abu Qir Fertilizers Company, November 2018

Abu Qir fertilizers Company, Egypt

Haldor Topsoe, Denmark

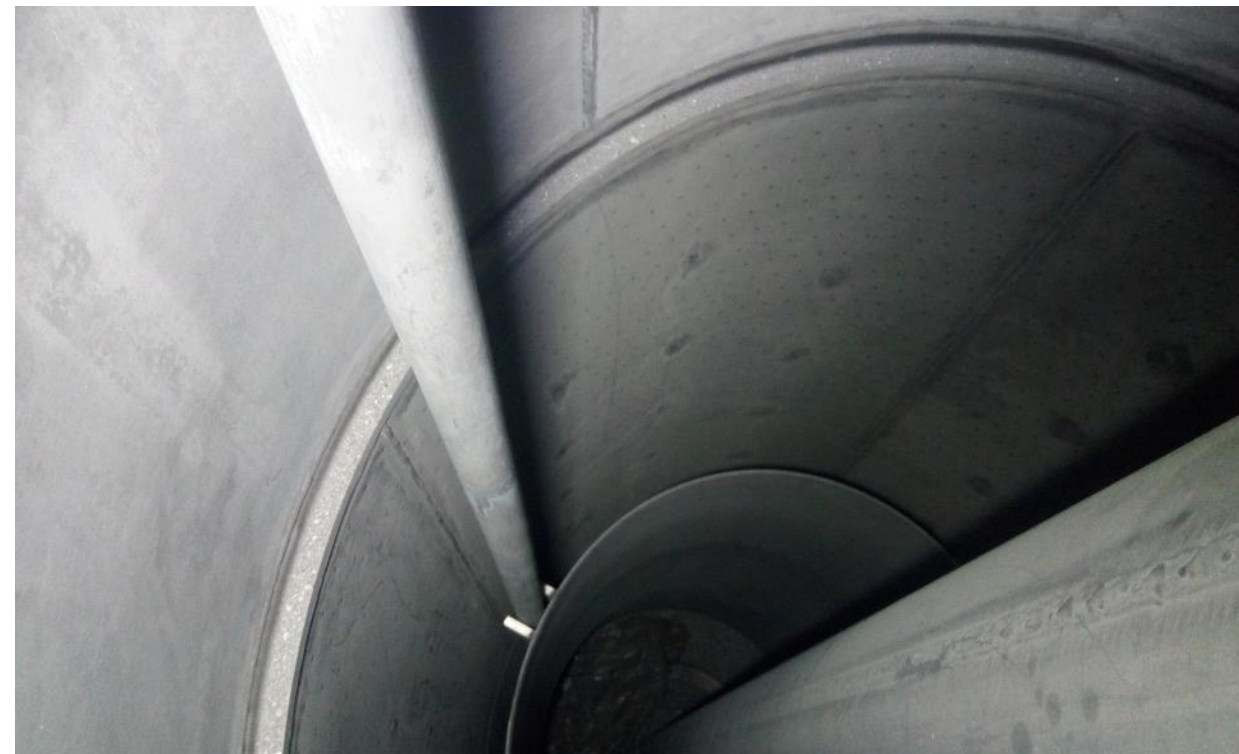
CENTER SCREEN

- When inspecting the first bed, the center and outer screens were found in good condition and no mechanical failures or ruptures were found.

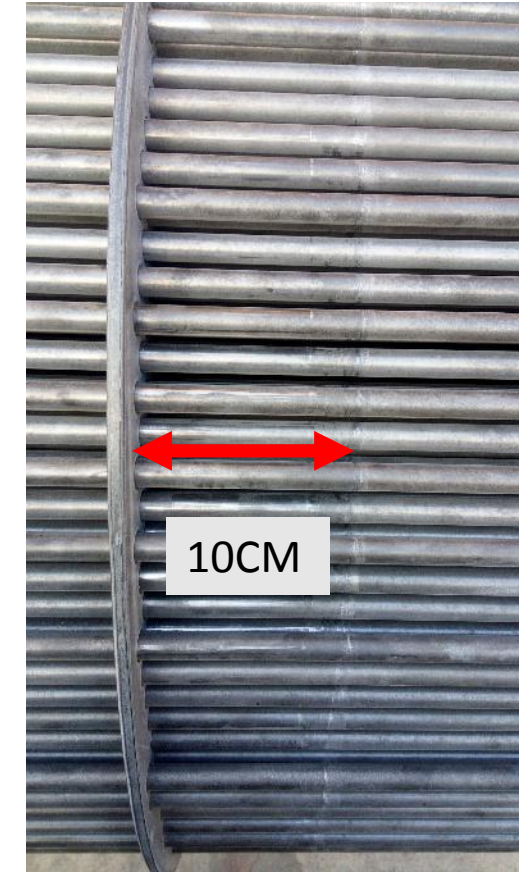
BAFFLES' ORIGINAL POSITION

- The intermediate upper heat exchanger was inspected, the baffles were found displaced by 100 mm towards lower direction, all baffles' tie rods were broken and the baffles were stuck at the new position and could not be repositioned.

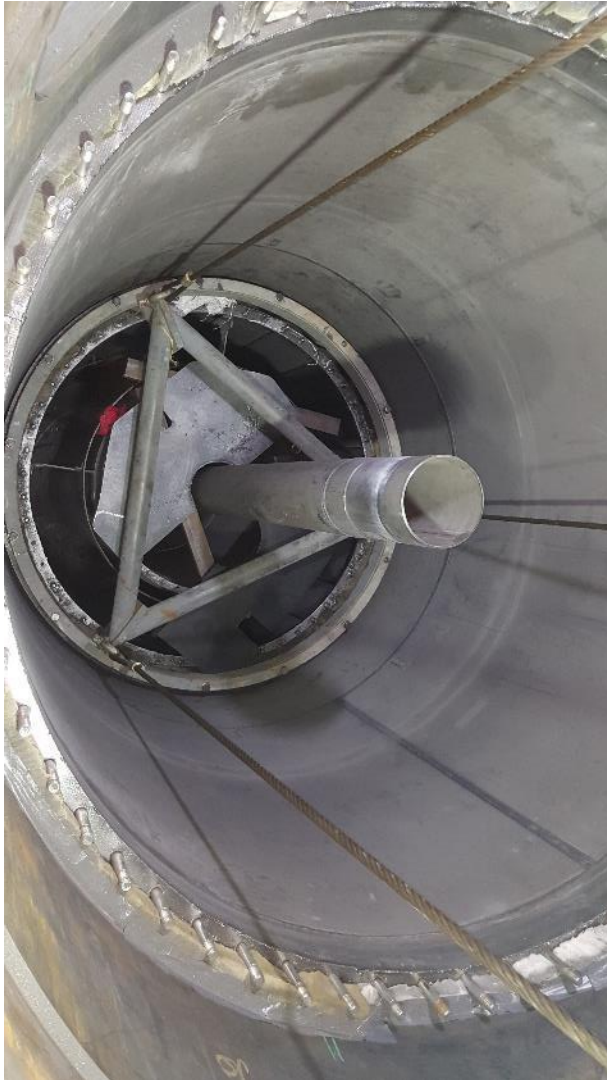
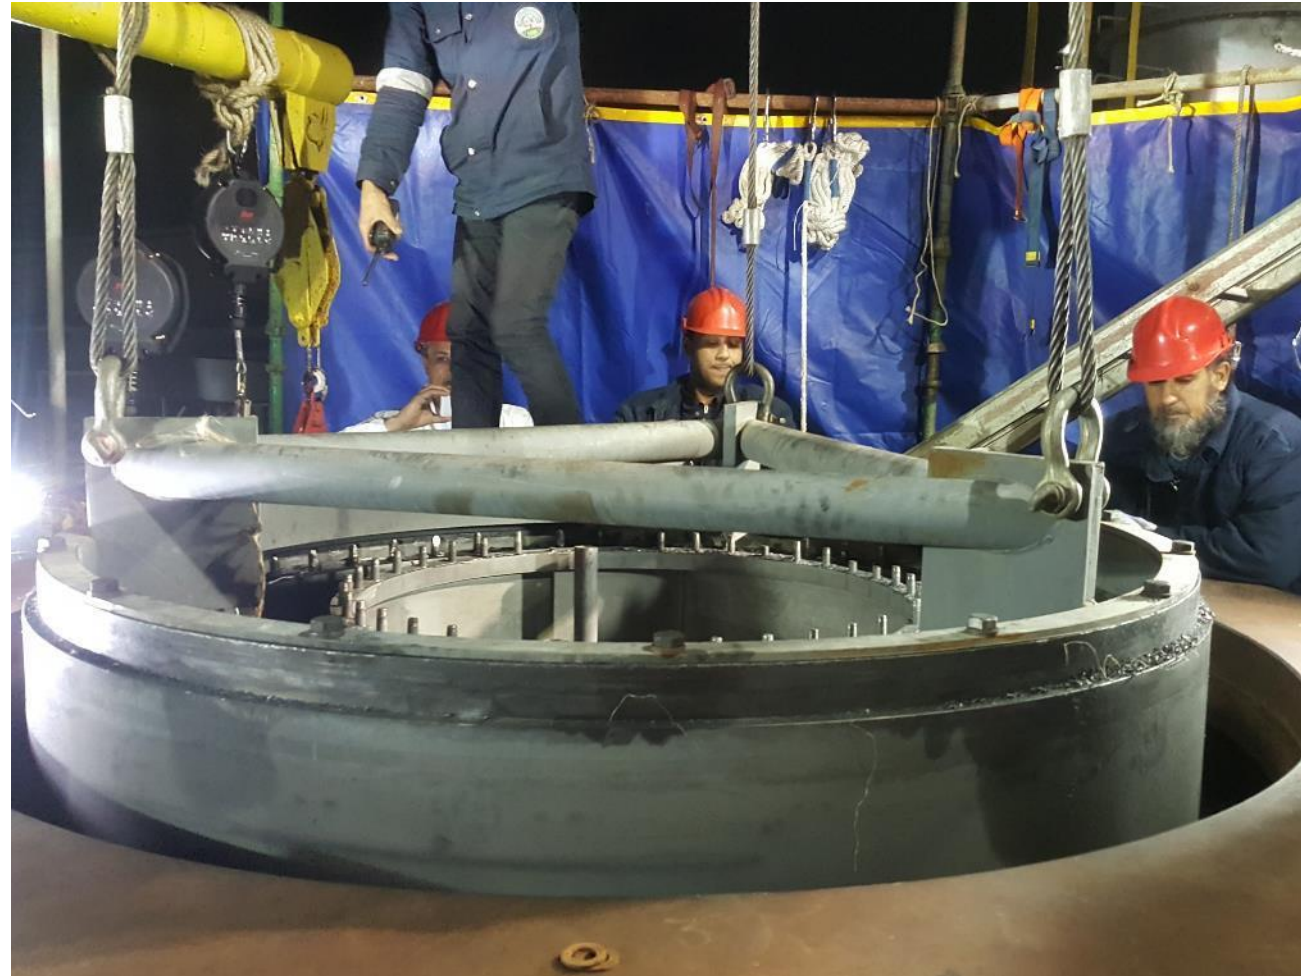
- The second bed's catalyst was unloaded.
- By inspecting, the center screen was found in good condition, some cracks were found in the outer screen due to long time operation at elevated temperatures but no major mechanical failures or rupture were found. Still the main problem cause was not reached.

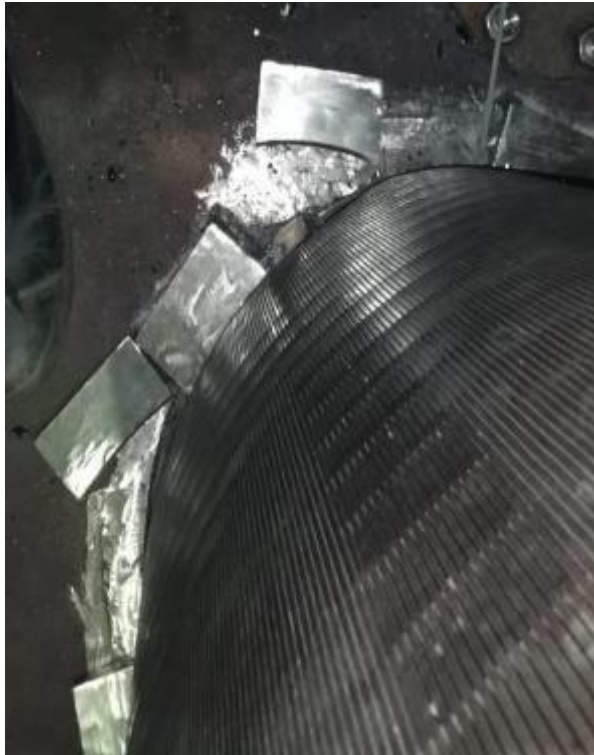
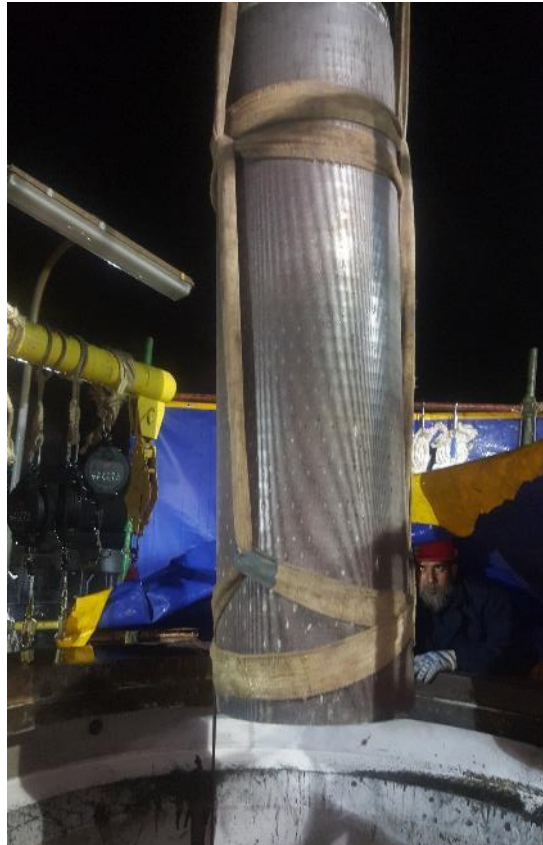
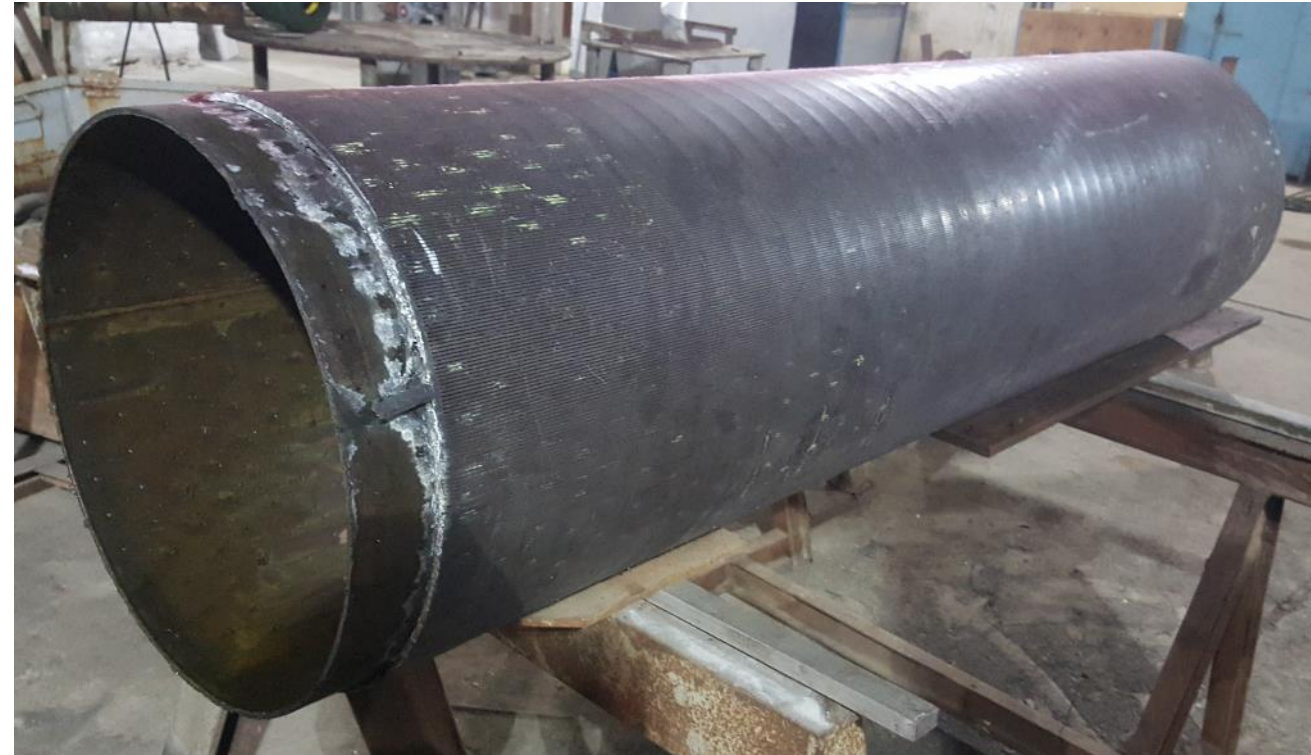
- By inspecting the center screen, a rupture was found at approximately 1.8 meter from bottom.

- The failure happened in a welding between the center screen's segments, nearly half of the circumference was crack opened of 5 cm.

- After long operating period under high pressure and temperature, the center screen material faced nitriding which increased the hardness of the surface making it more prone to surface cracks.
- Due to the extensive number of startups/shutdowns, the center screen have been exposed to many cycles of thermal and mechanical stresses, progressively weakened and fatigued the material.
- The center screen was exposed to a high mechanical load, during the sudden plant stoppage as caused by the power failure.
- The rupture of the fatigued material was caused by a combination of the above factors and ultimately by the power failure that the plant suffered from.

- The locking clips of the center screen were grinded off, the center screen was removed out to allow the repair process.

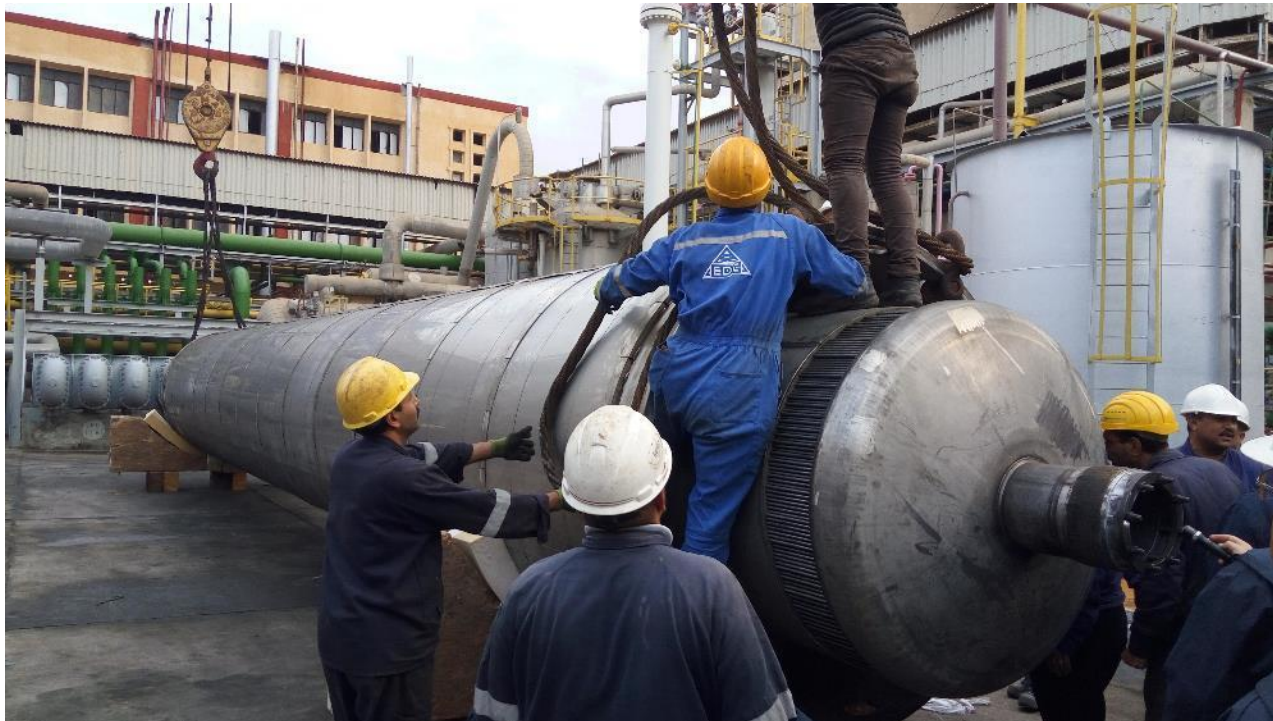
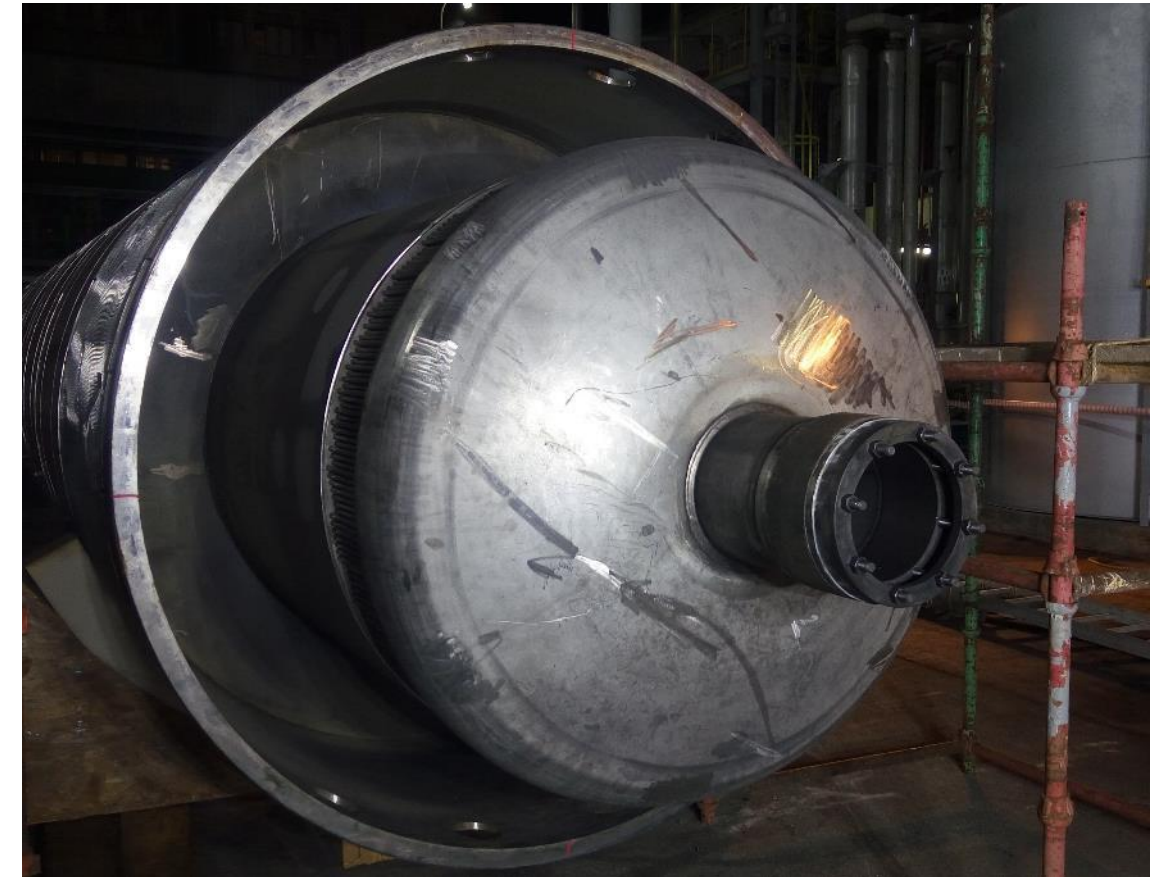
- When the center screen was removed, it was found that catalyst escaped from the center screen rupture and trapped in the chamber between the basket's bottom and the lower heat exchanger's tube sheet.
- The escaped catalyst was sintered and the tube sheet appeared affected and blocked by the migrated catalyst.
- Since there was no access to that heat exchanger below the basket, it was decided to lift up the basket out of the vessel to inspect and clean the tube sheet and also to remove the remaining trapped catalyst.

- To gain access to cut out the heat exchanger, three windows were cut in the basket's lower skirt to reveal the shroud between the tube sheet and the basket's bottom.

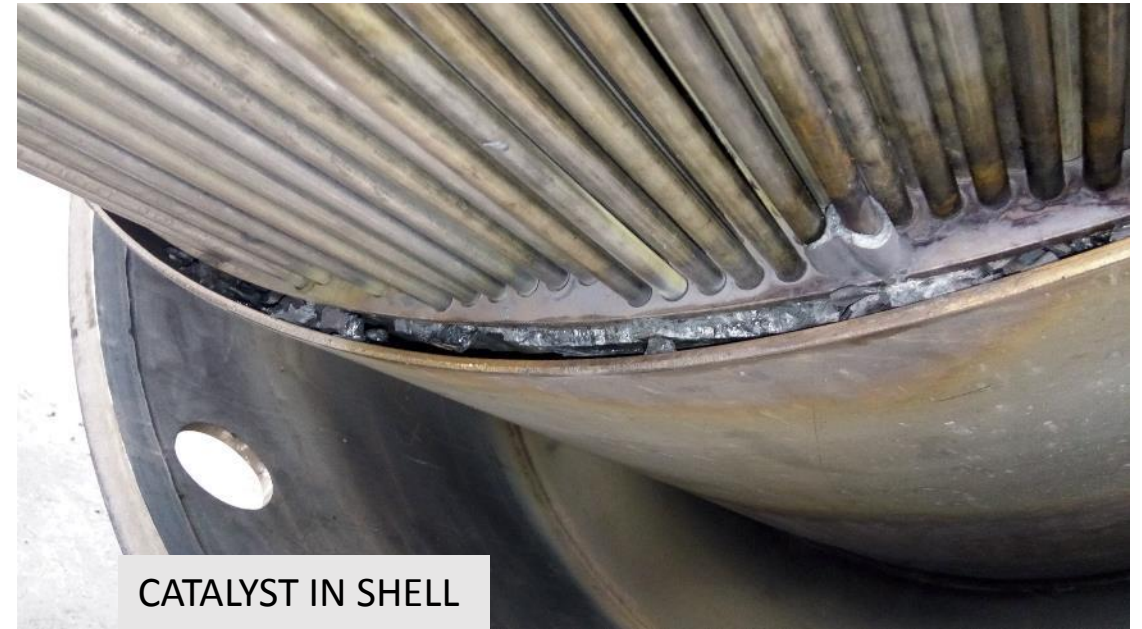
CATALYST IN SHELL

- The lower heat exchanger was cut out and inspected.
- All exchanger tubes were filled and plugged with catalyst. The upper tube sheet was damaged and fused on 90% of its area as well as 90% of tube to tube sheet weldings.
- It was also noticed that many tubes were ruptured enabling catalyst to enter the shell side.

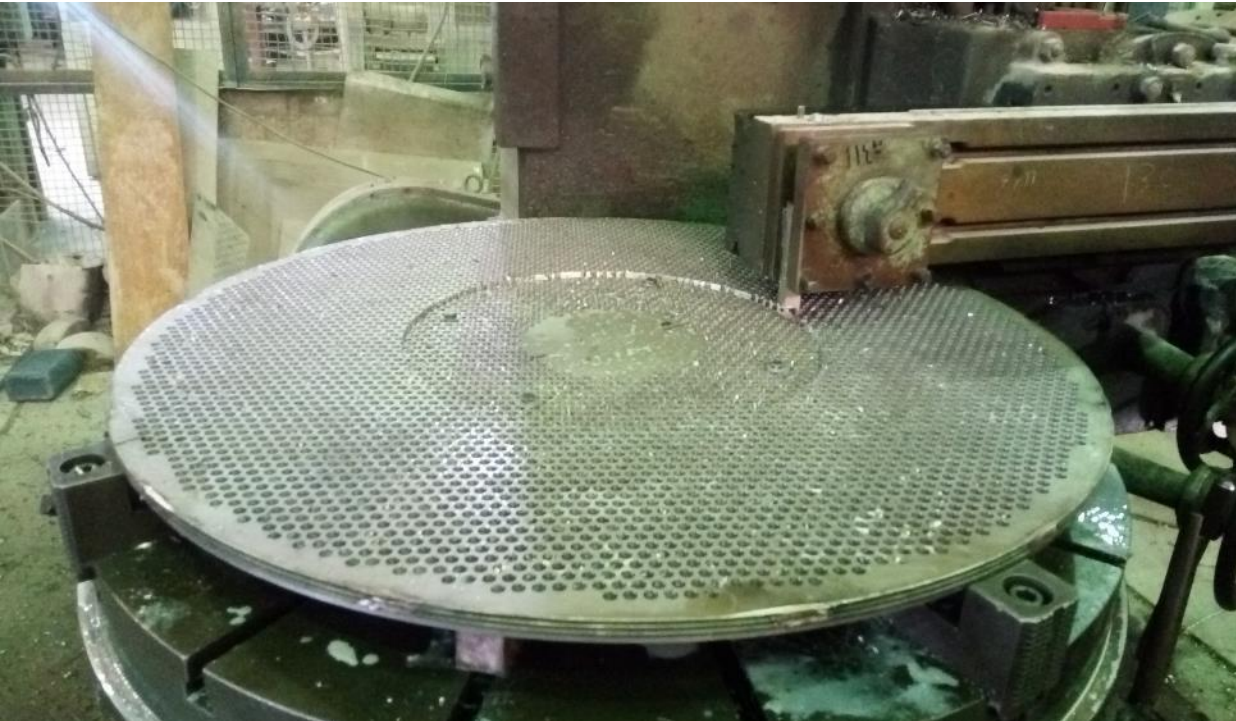
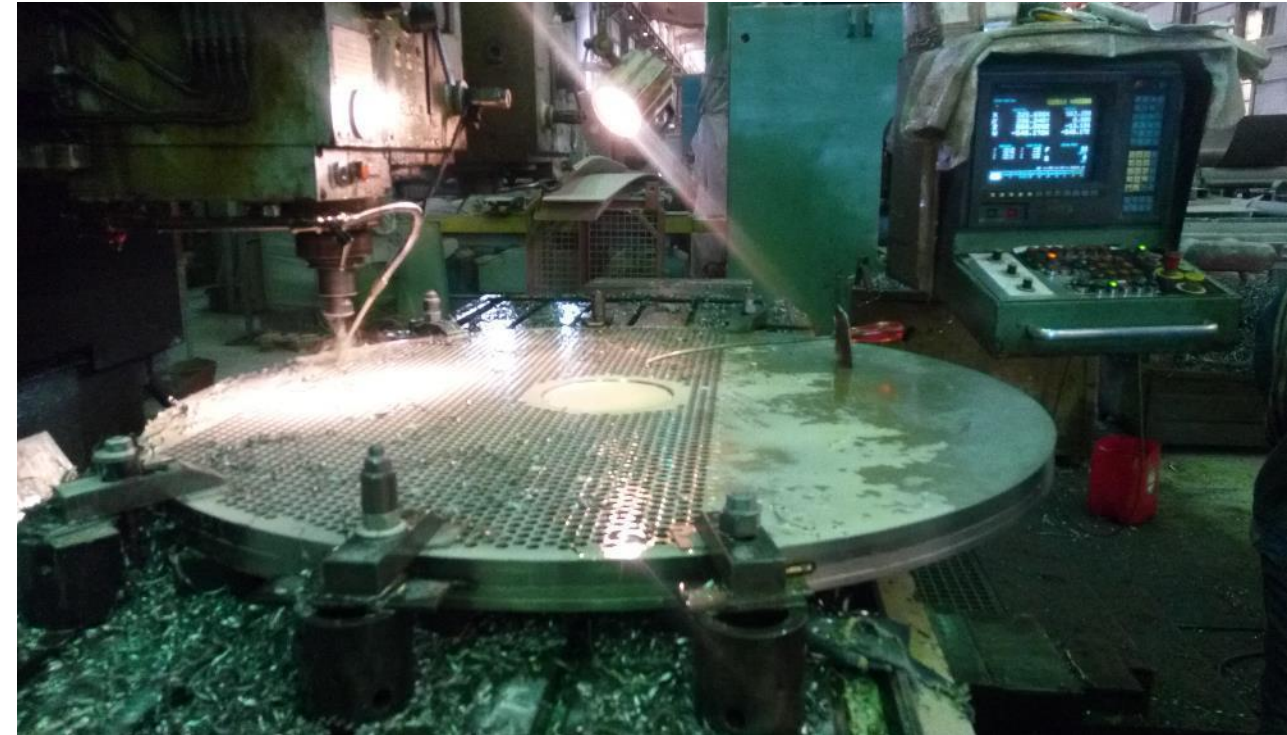
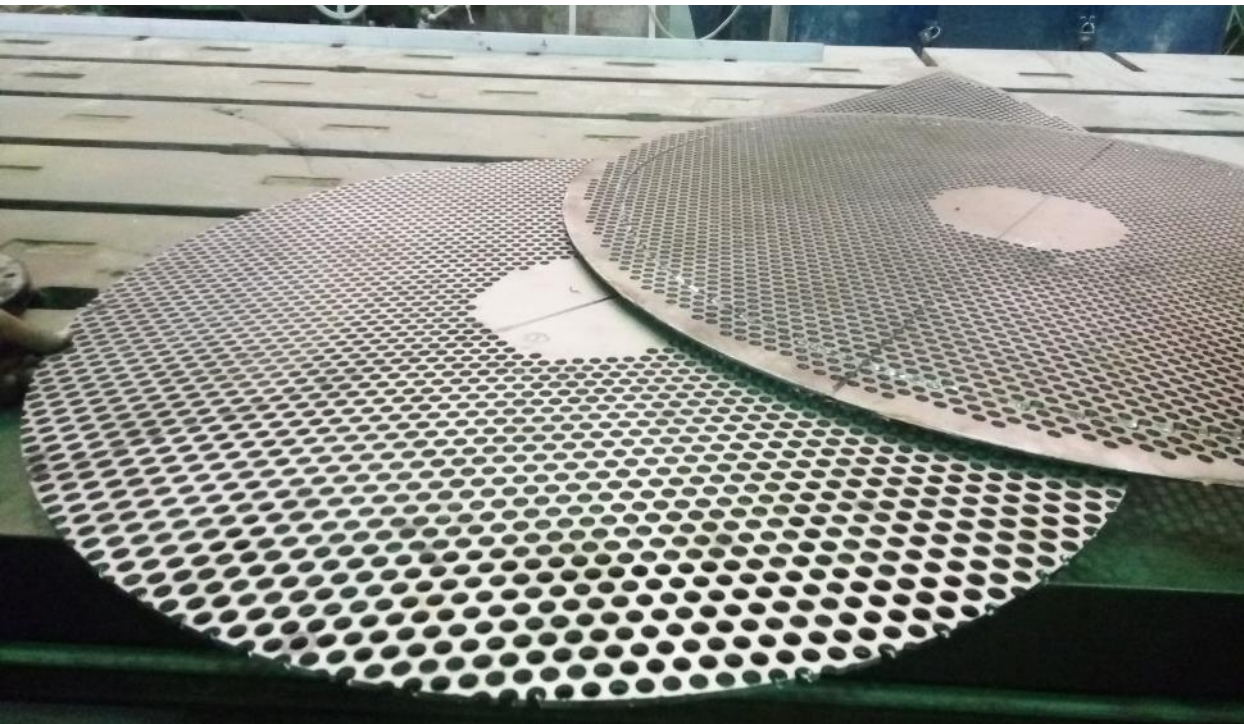
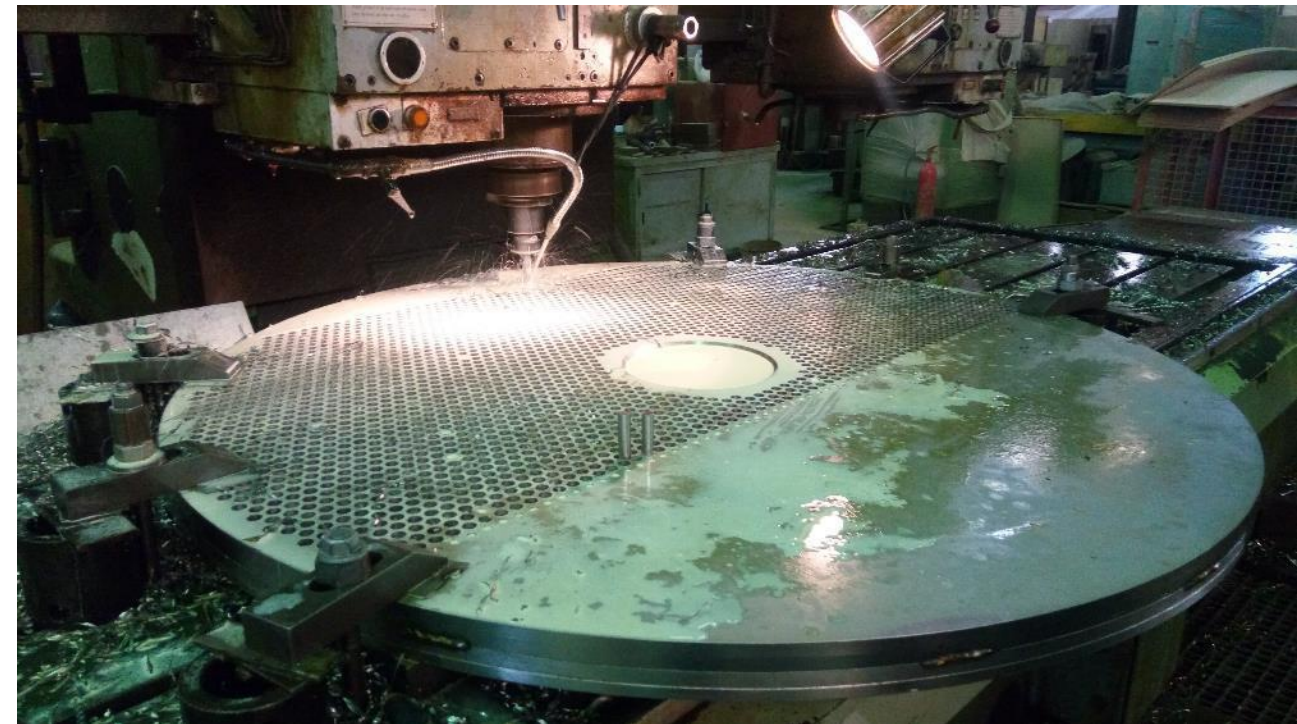
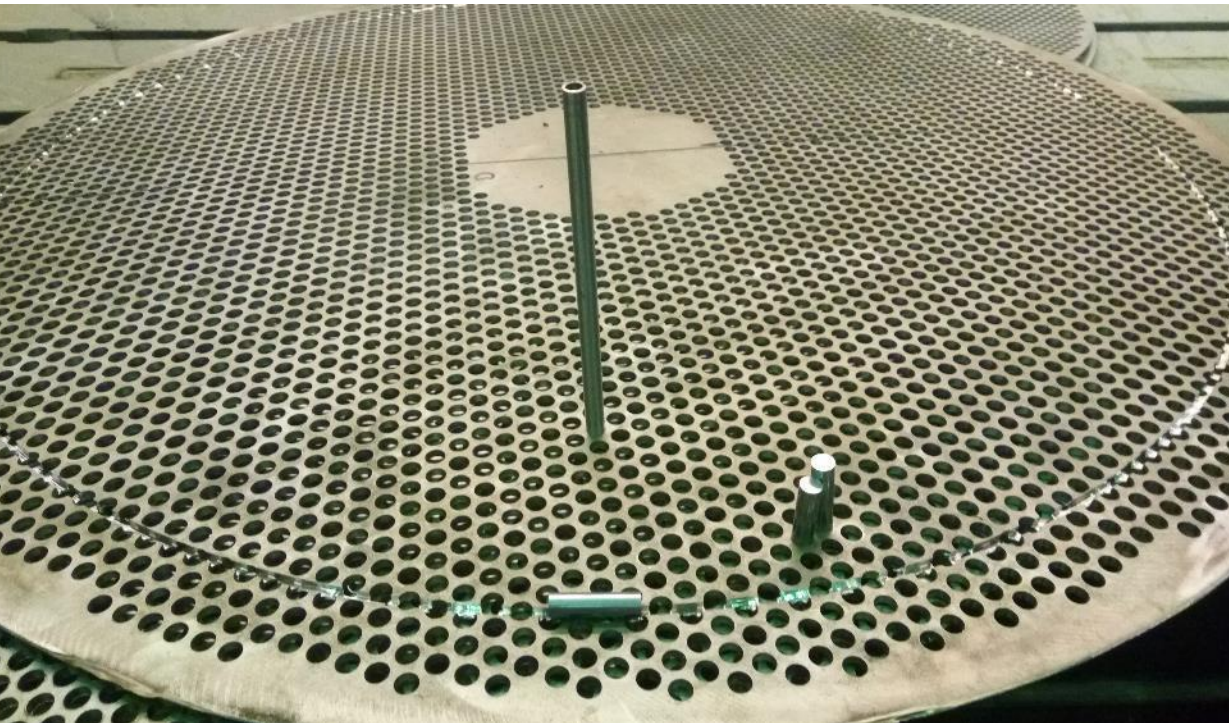
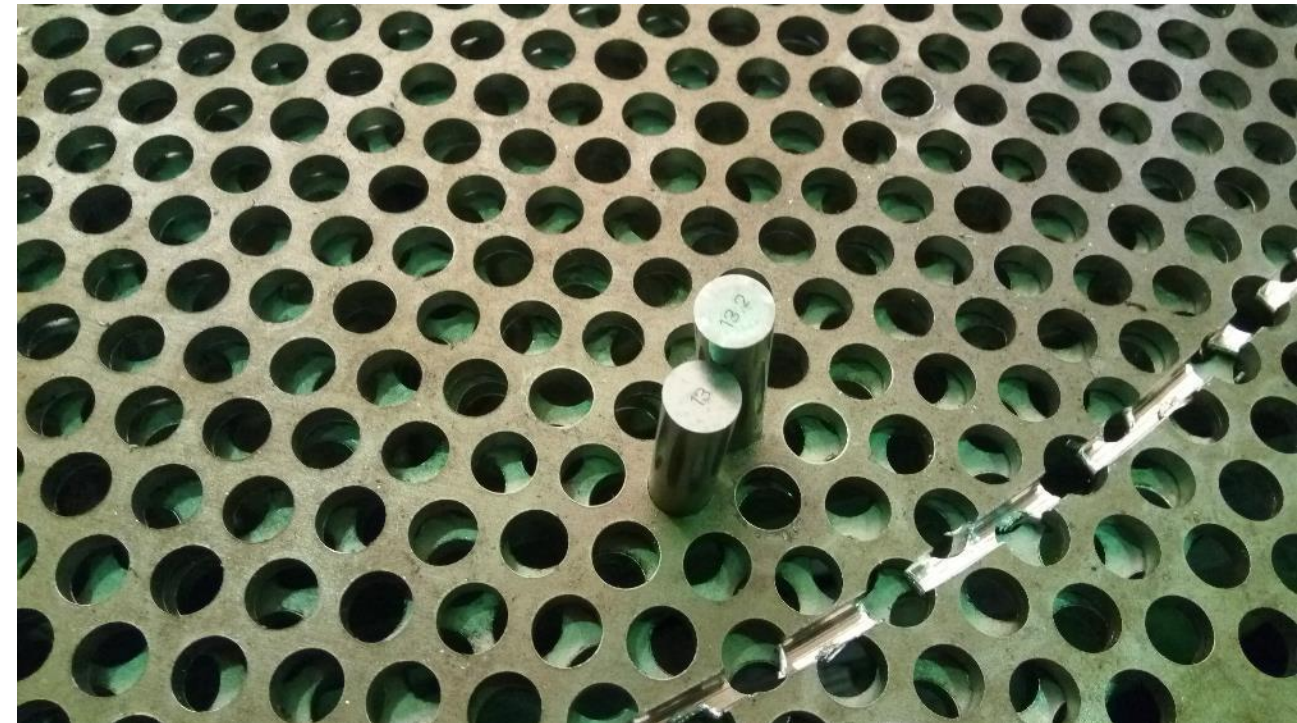
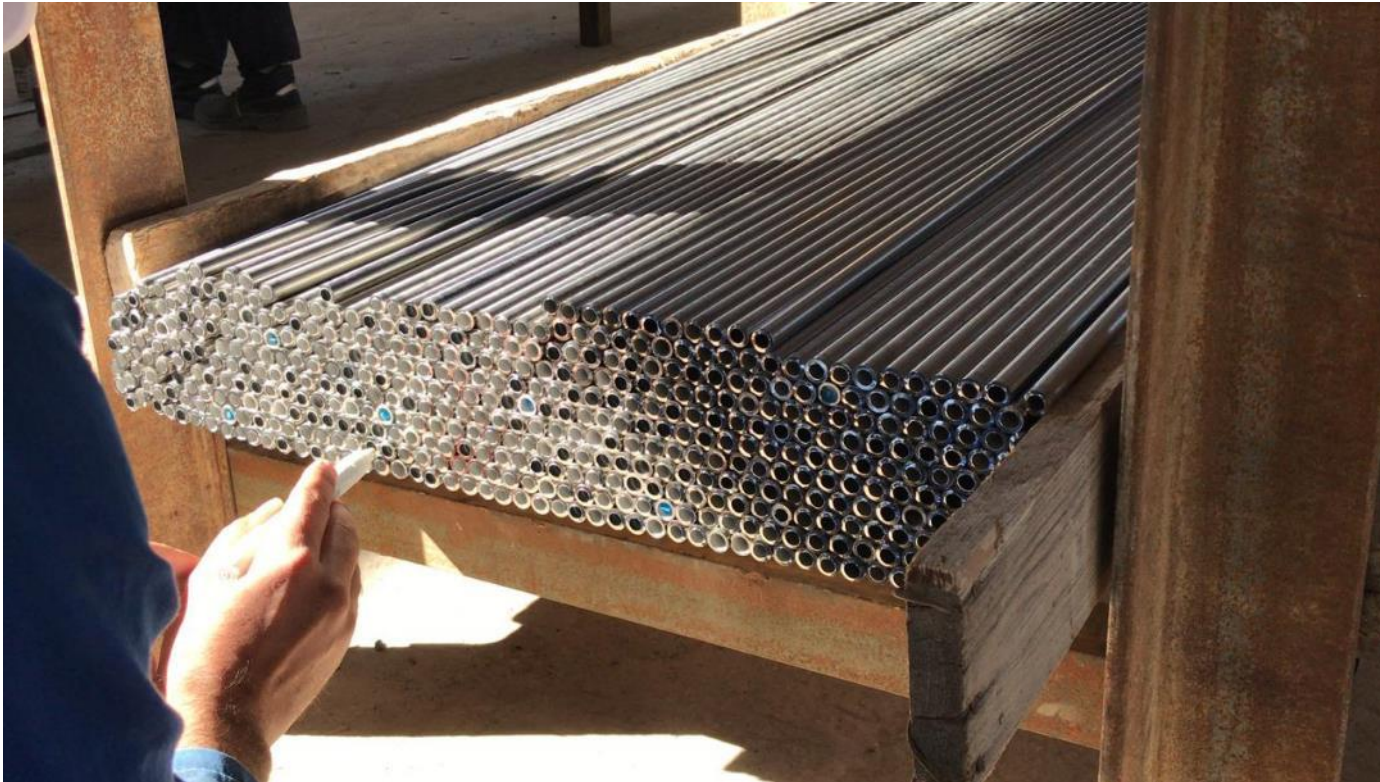
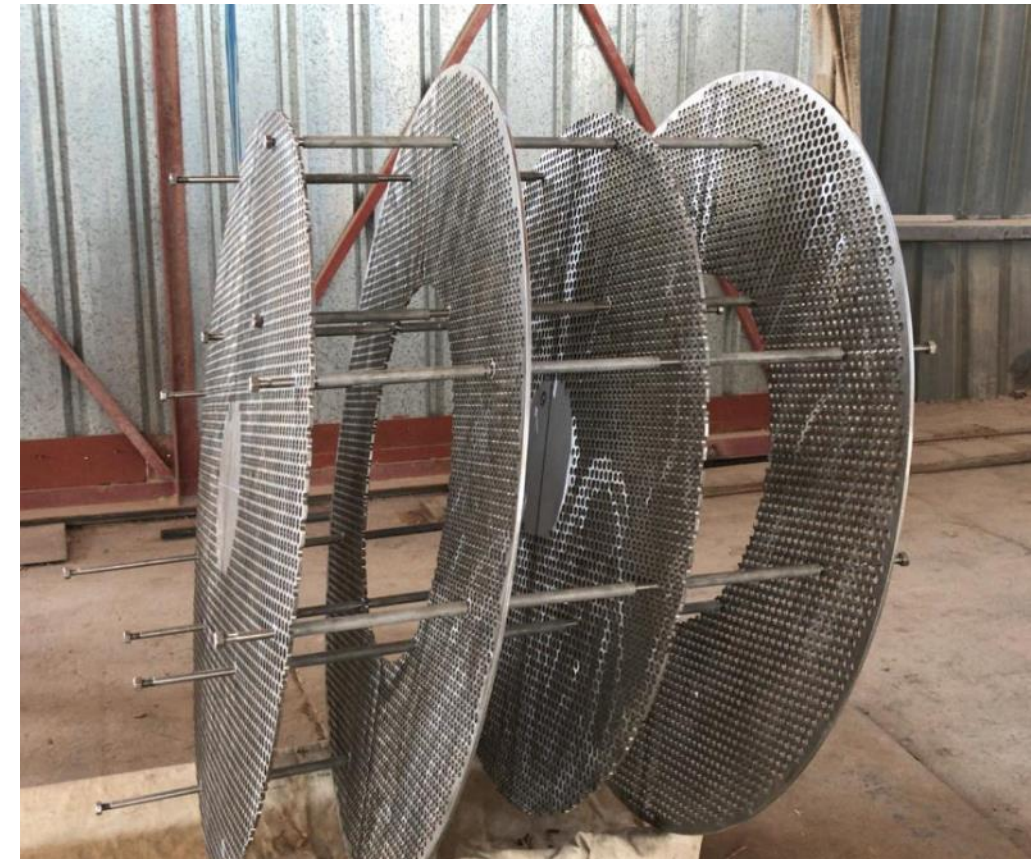
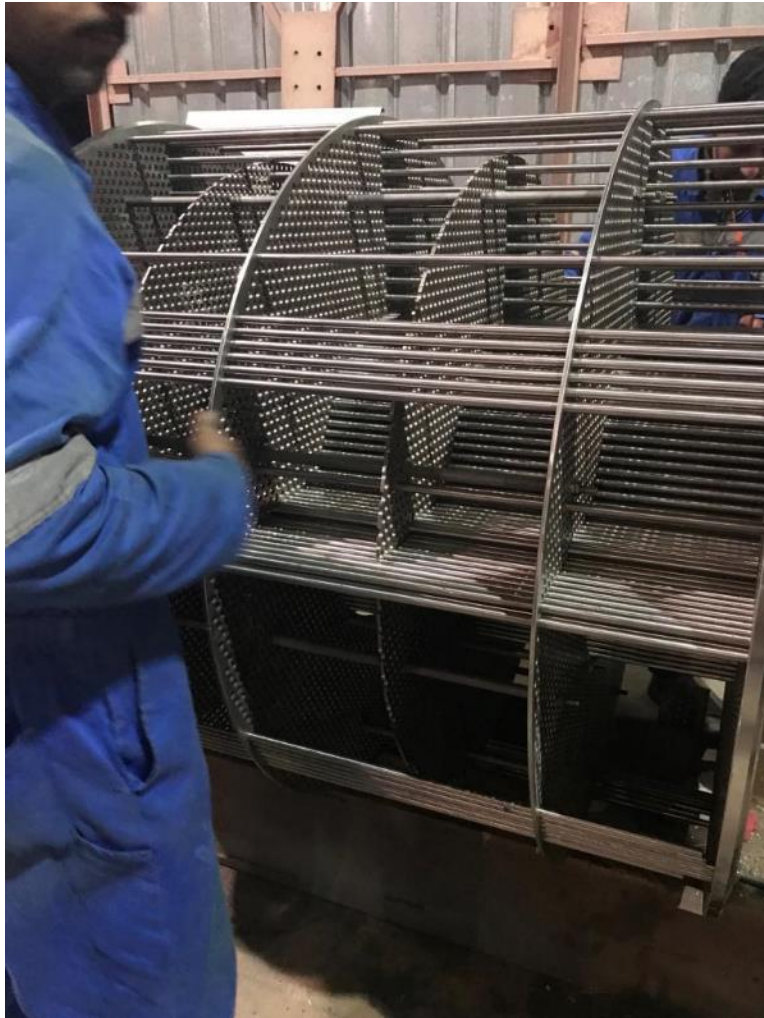
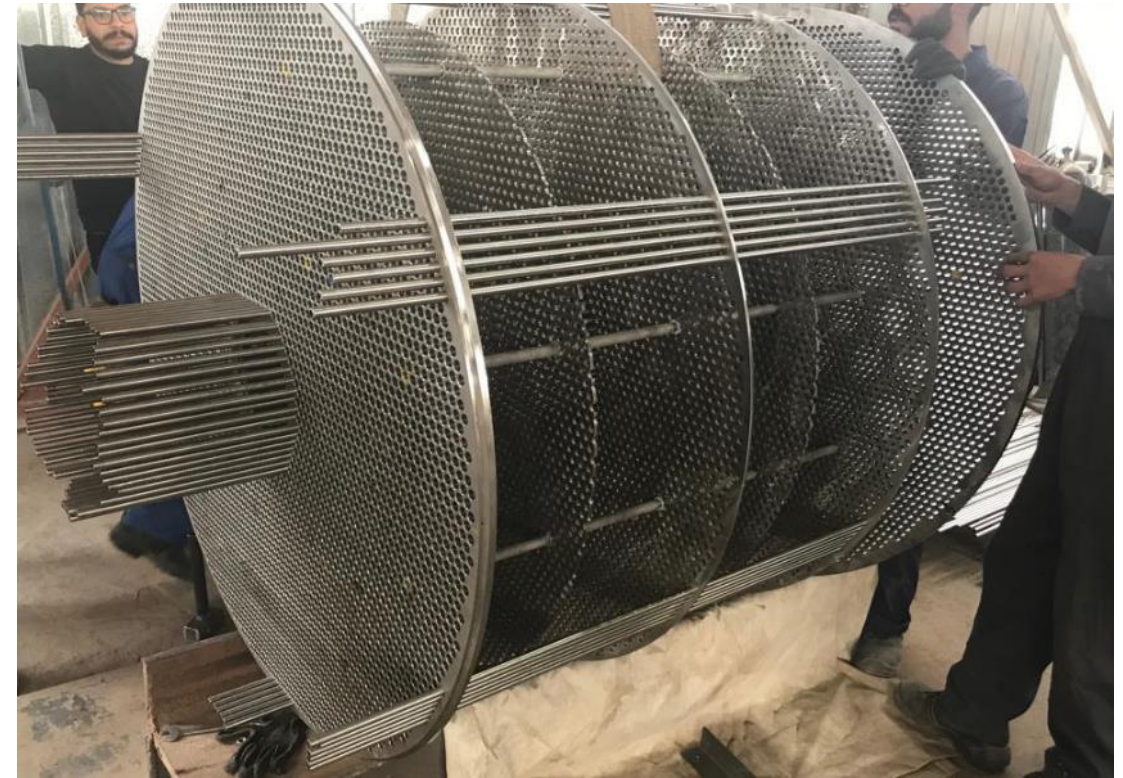
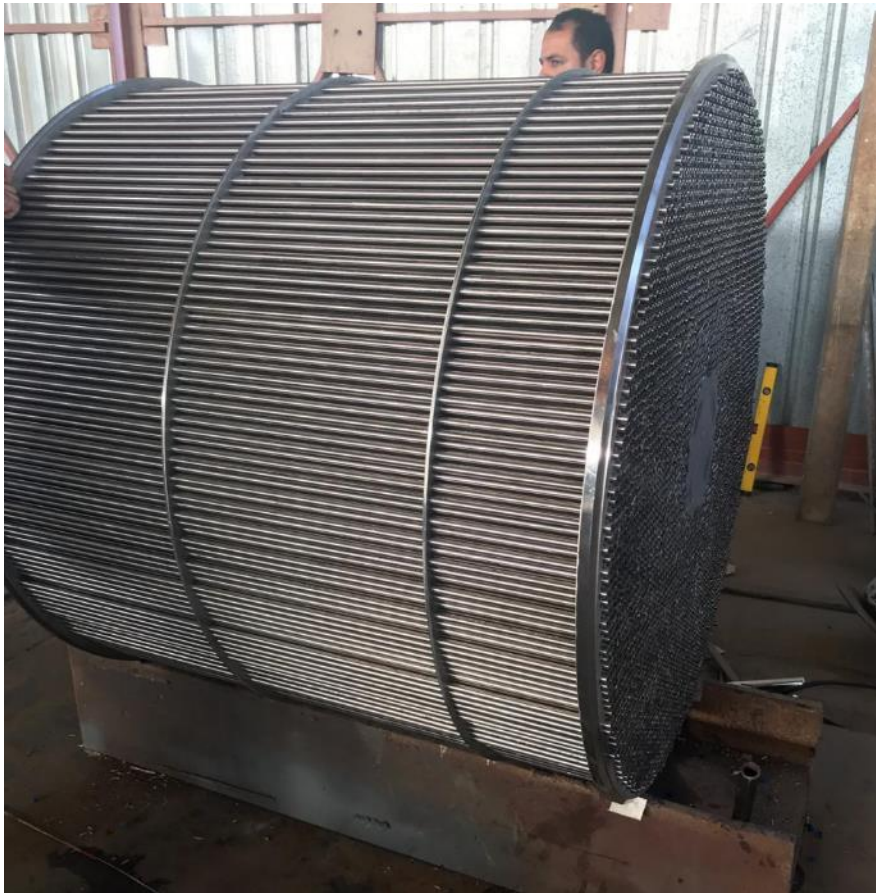
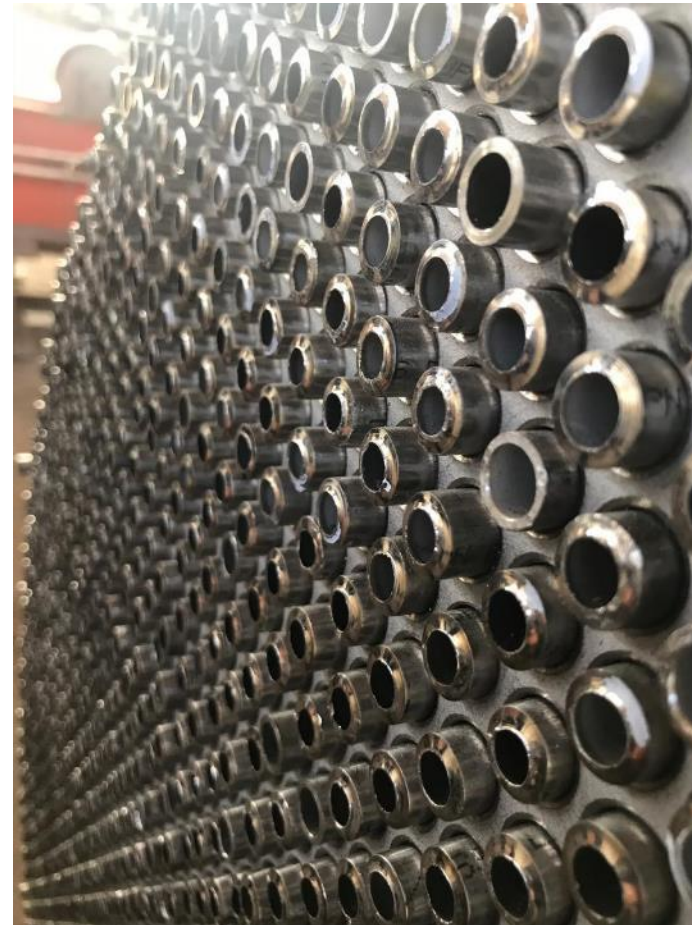
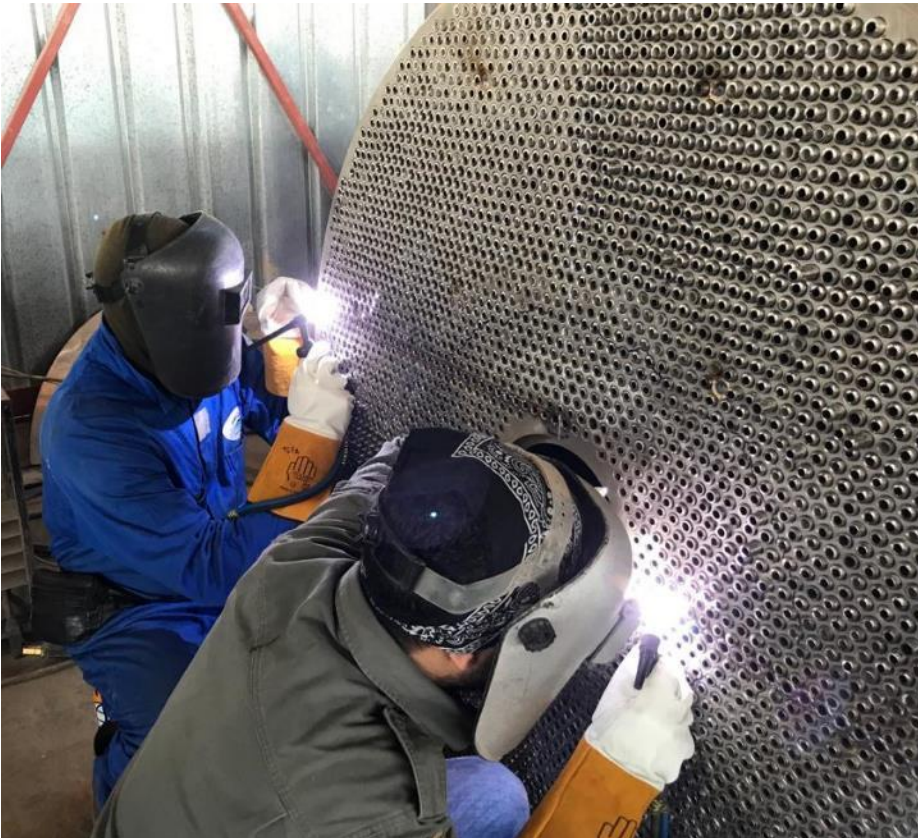
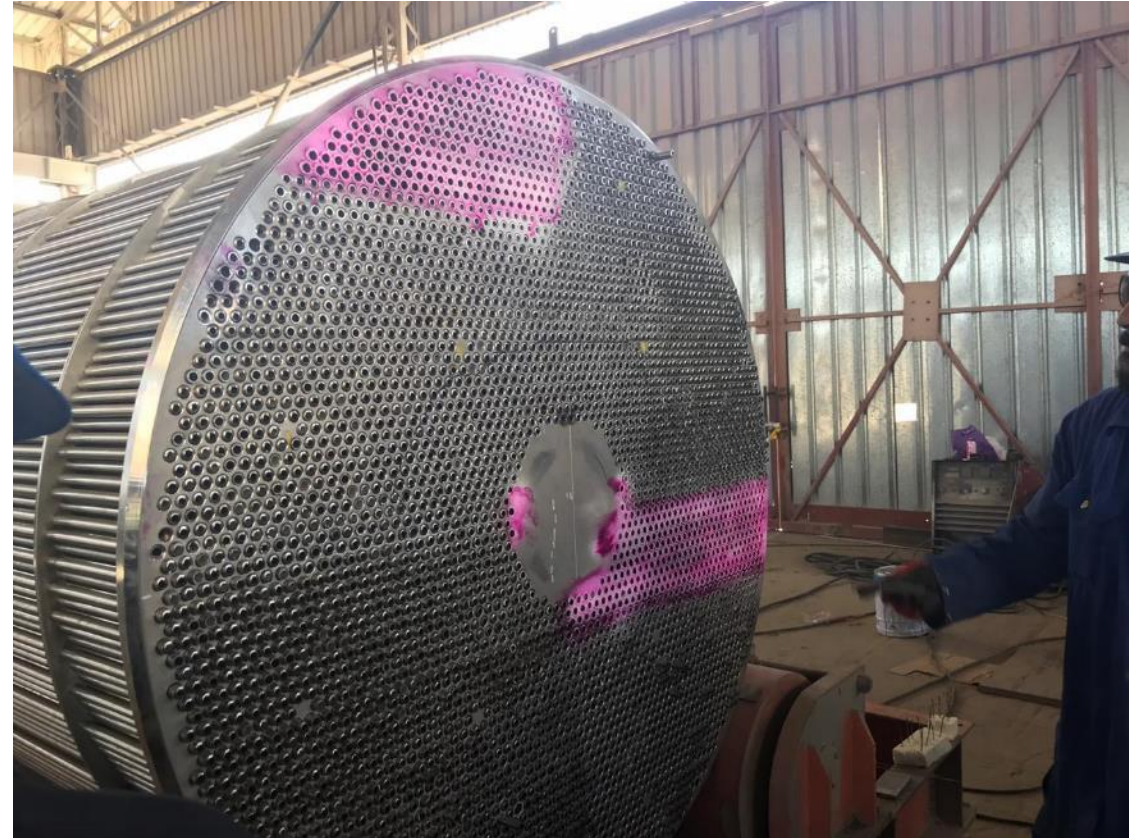
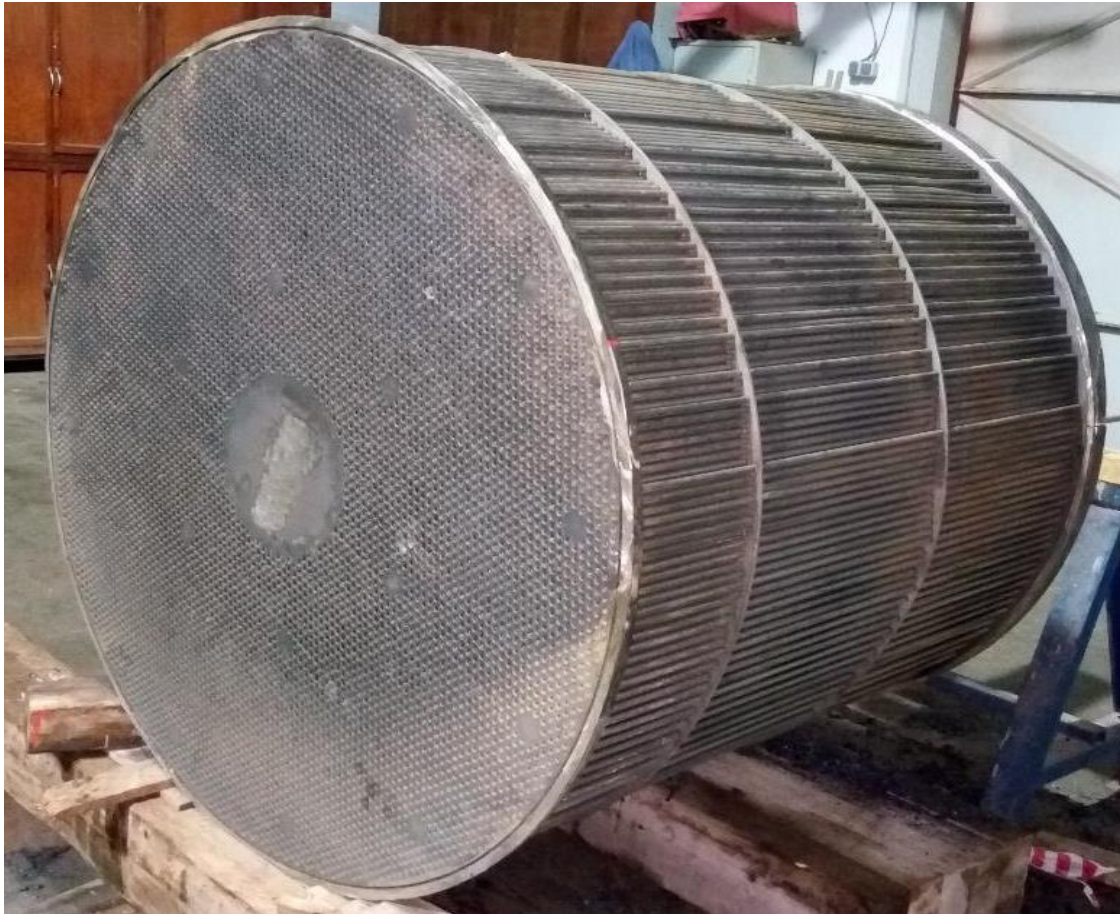
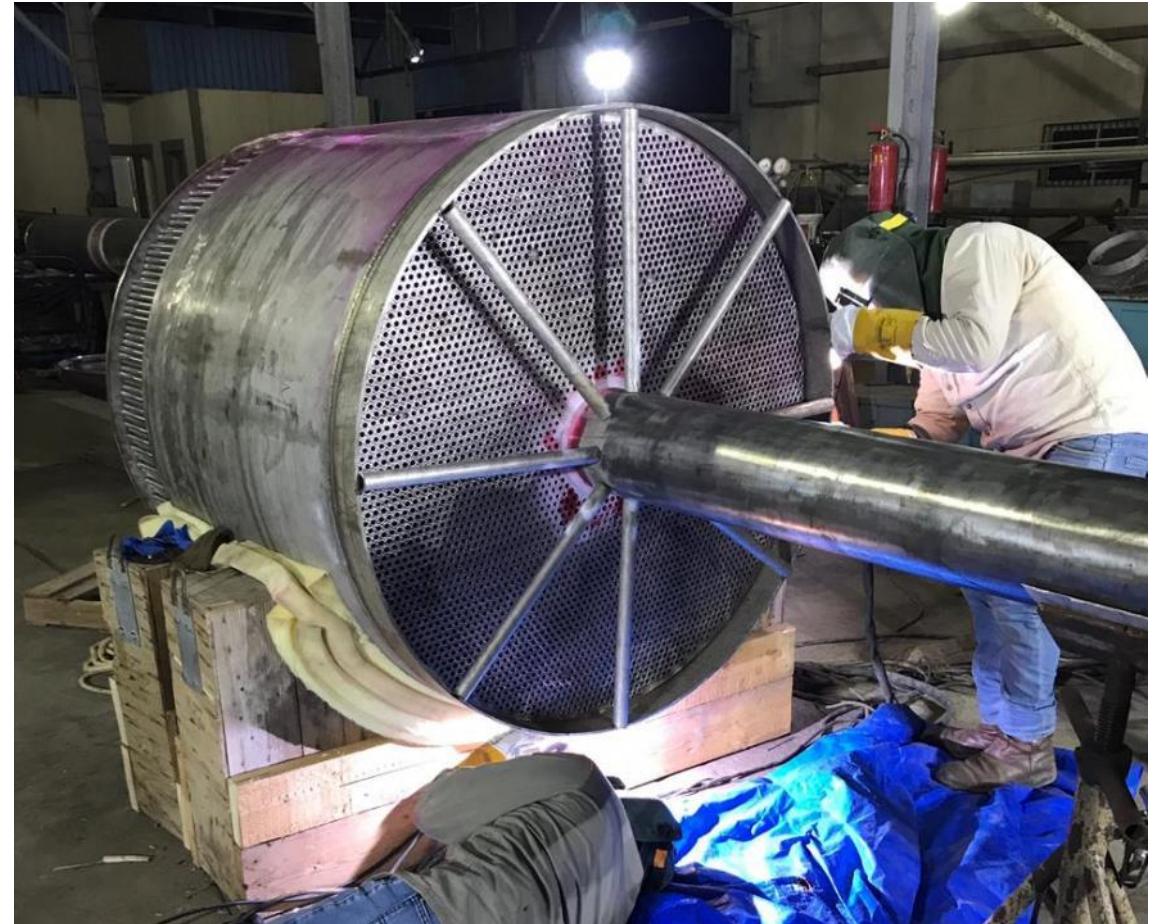
- Lower heat exchanger manufacturing:
