Repair of ammonia converter's basket in Abu Qir Fertilizers Company, November 2018

Abu Qir fertilizers Company, Egypt

Haldor Topsoe, Denmark

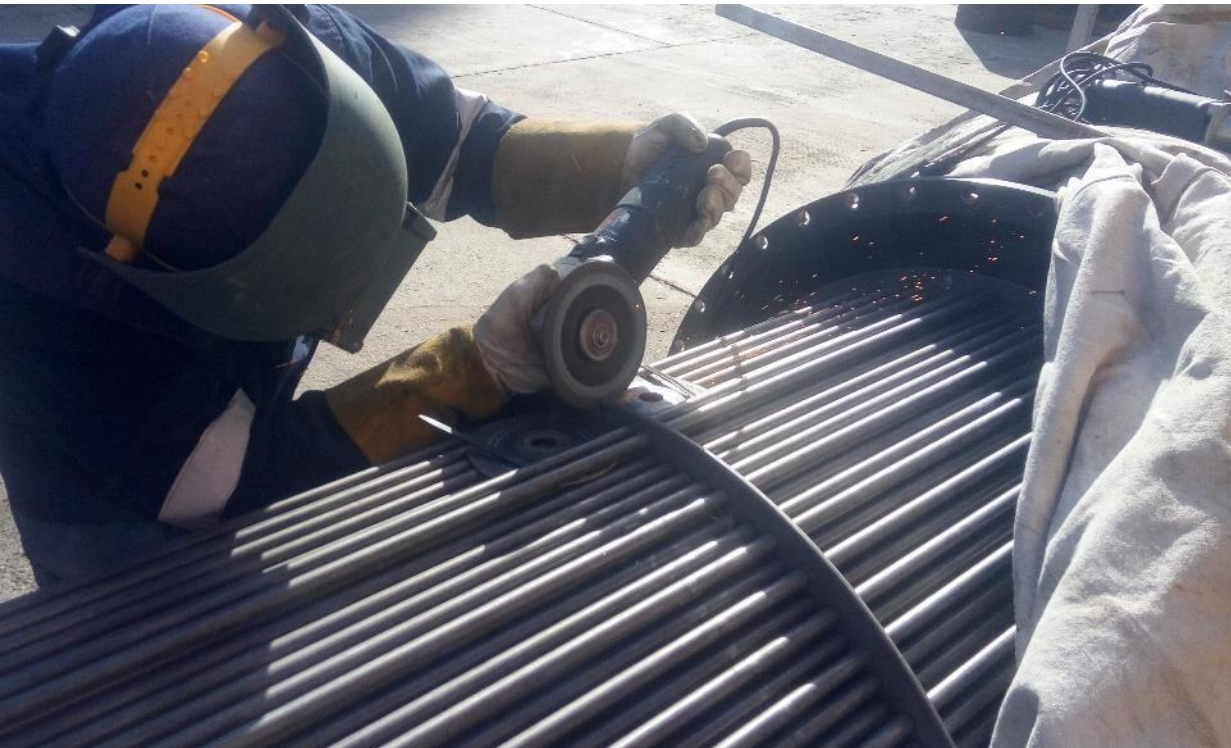
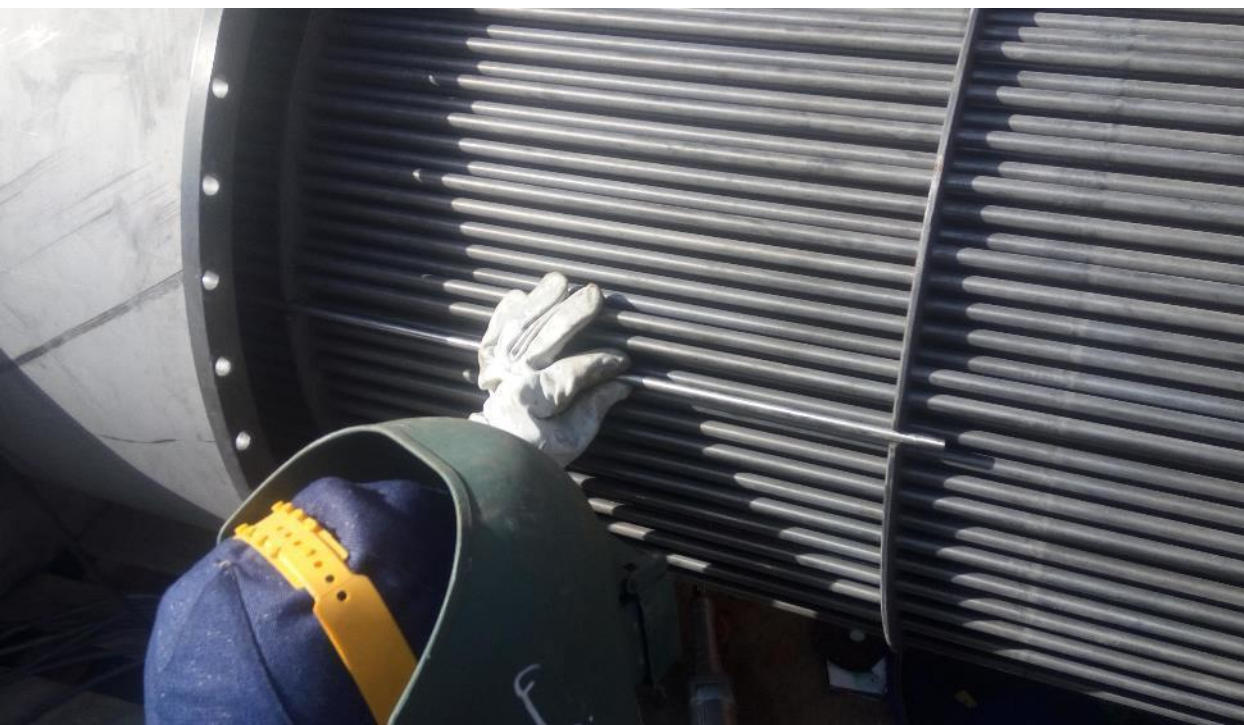
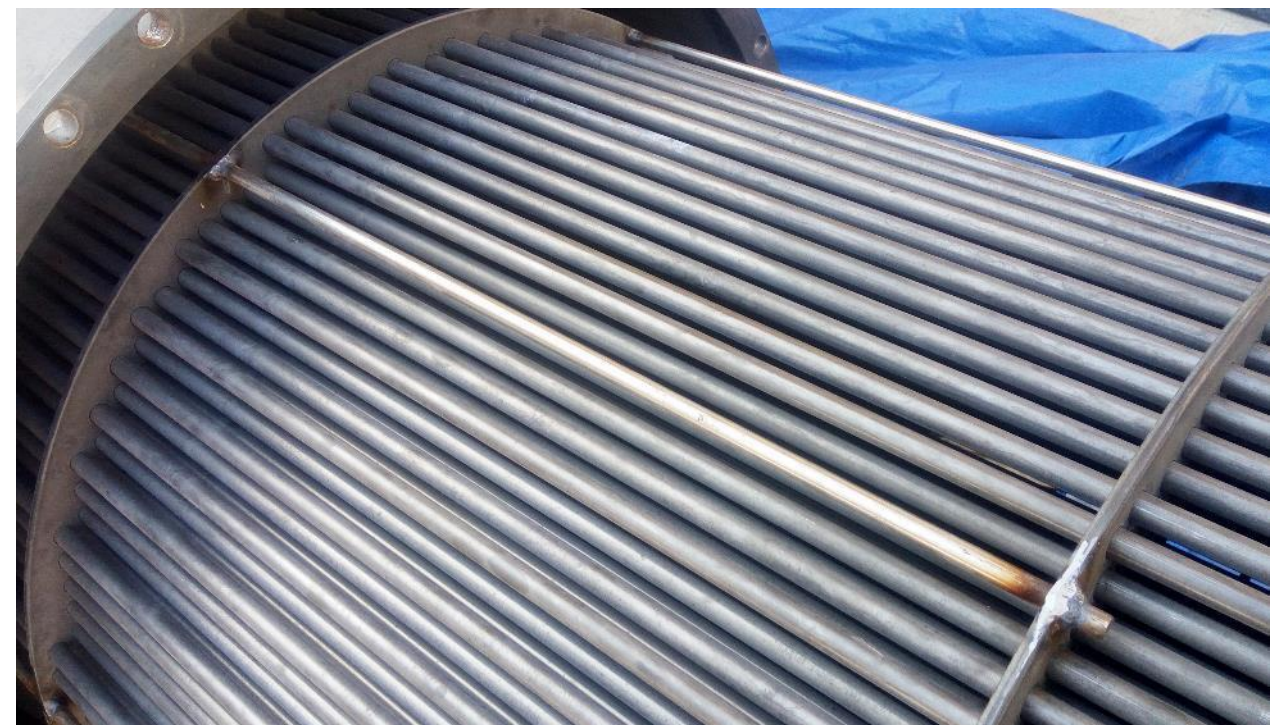
- The intermediate upper heat exchanger was inspected, the baffles were found displaced by 100 mm towards lower direction, all baffles' tie rods were broken and the baffles were stuck at the new position and could not be repositioned.

- For The upper heat exchanger, new tie rods were welded to fix the baffles at the new positions.
- A simulation was carried out by Haldor Topsoe and the CFD study concluded that there will be no remarkable effect on the exchanger's performance.

- The upper heat exchanger, new tie rods were welded to fix the baffles at the new positions.
- A simulation was carried out by Haldor Topsoe and the CFD study concluded that there will be no remarkable effect on the exchanger's performance.

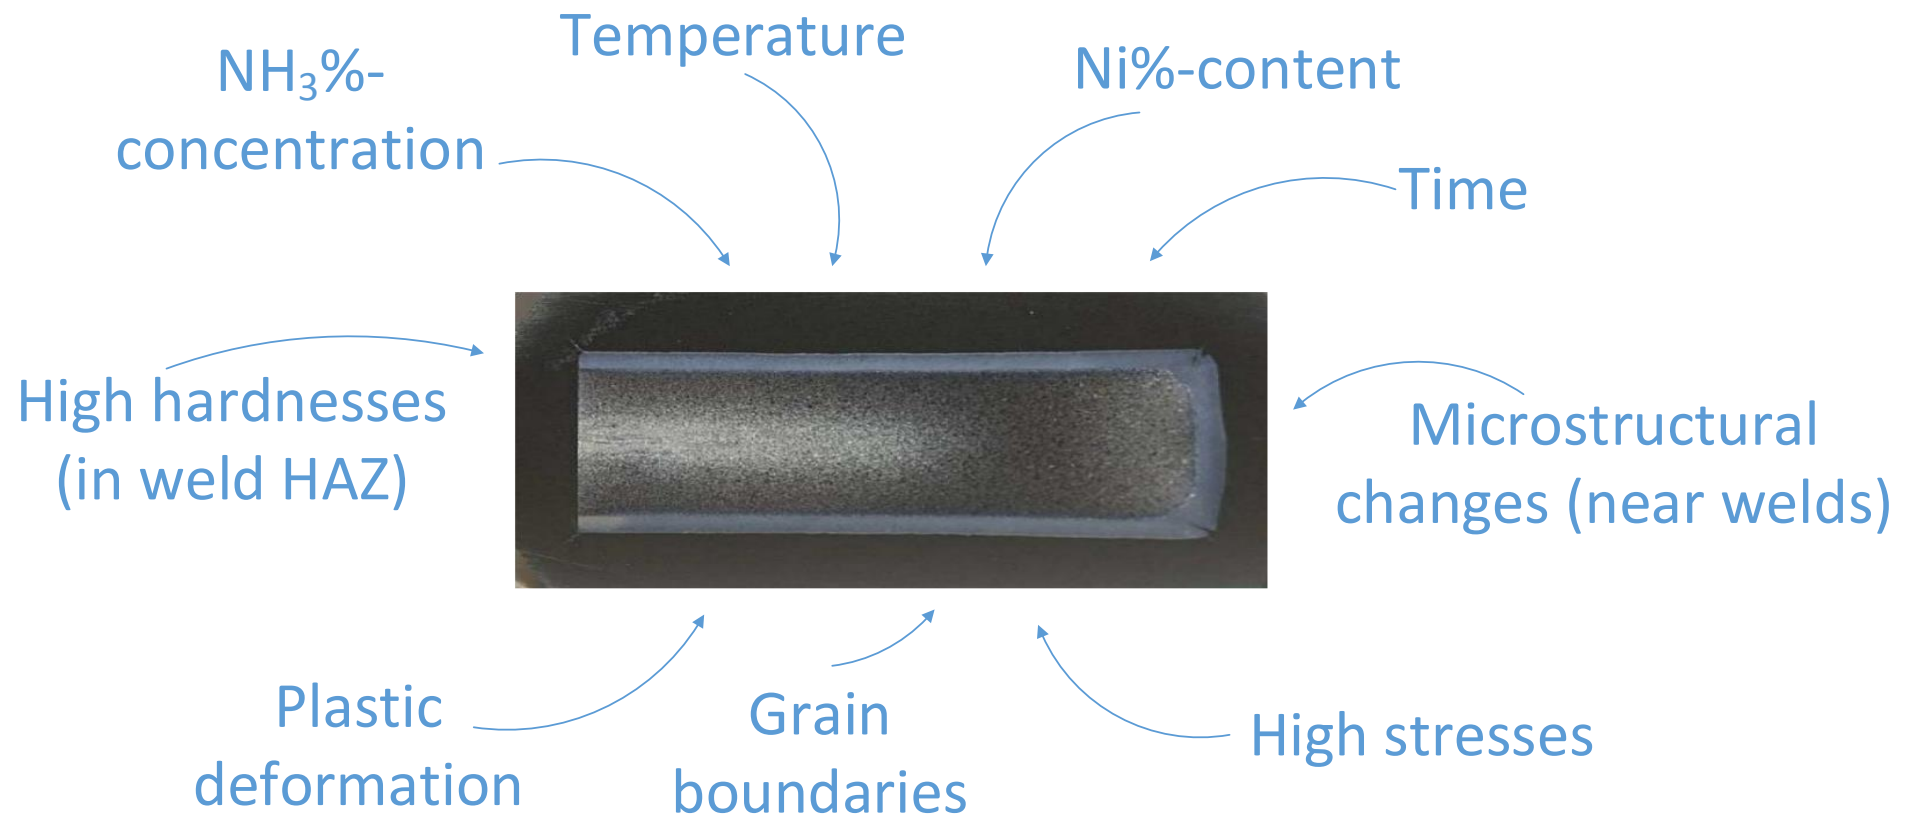
- **Nitriding.**

- After long operating period under high pressure and temperature, the center screen material faced nitriding which increased the hardness of the surface making it more prone to surface cracks.
- Due to the extensive number of startups/shutdowns, the center screen have been exposed to many cycles of thermal and mechanical stresses, progressively weakened and fatigued the material.
- The center screen was exposed to a high mechanical load, during the sudden plant stoppage as caused by the power failure.
- The rupture of the fatigued material was caused by a combination of the above factors and ultimately by the power failure that the plant suffered from.

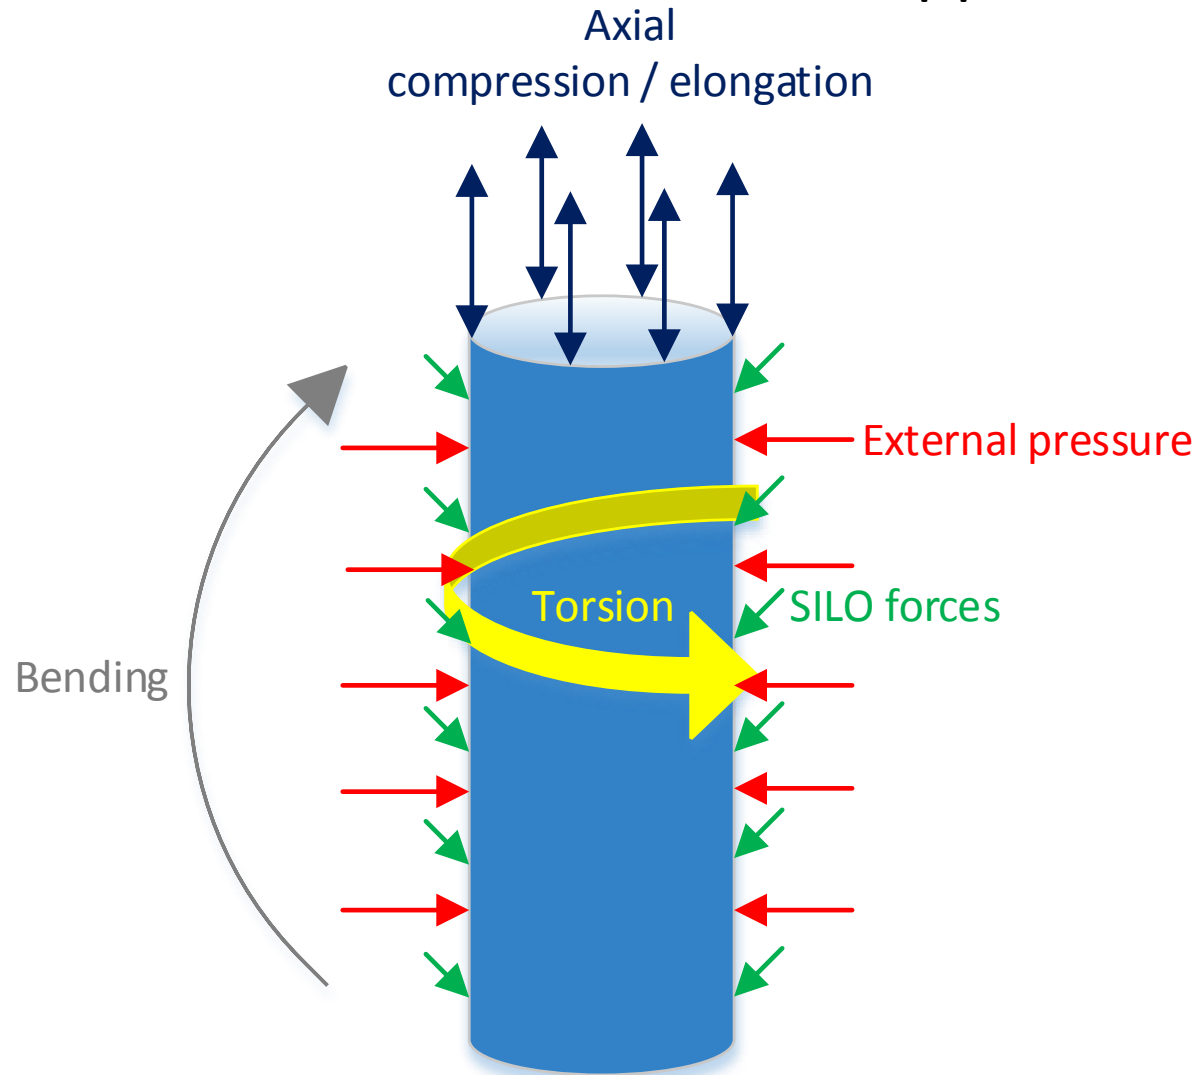
- Mechanical loads.

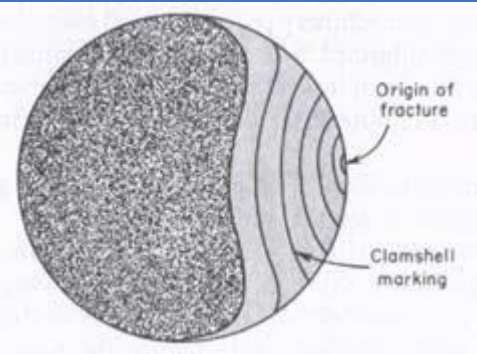
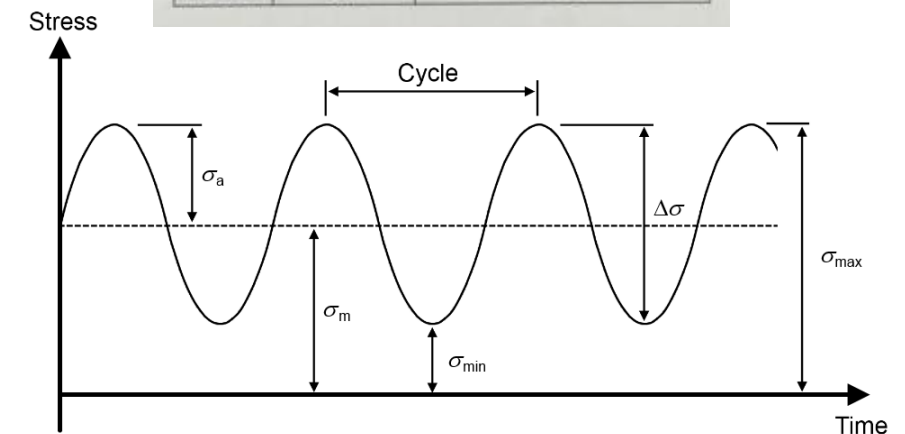
- Thermal stress and cyclic loads - Fatigue

Too fast start startup (high temperature gradient)	Increased axial compression on center screen
	Too fast shutdown (high temperature gradient)	Increased axial elongation on center screen
	Uneven temperature distribution due to unsymmetrical activation of catalyst (hot side + cold side)	Increased bending stresses on center screen ("Banana shape")
	Excessive number of load cycles	Fatigue

Year	Startups	Shutdowns & Trips
2005	5	4
2006	5	5
2007	4	4
2008	3	3
2009	1	1
2010	9	9
2011	5	5
2012	8	8
2013	6	6
2014	8	8
2015	10	10
2016	5	5
2017	3	3
2018	9	10
Total	81	81

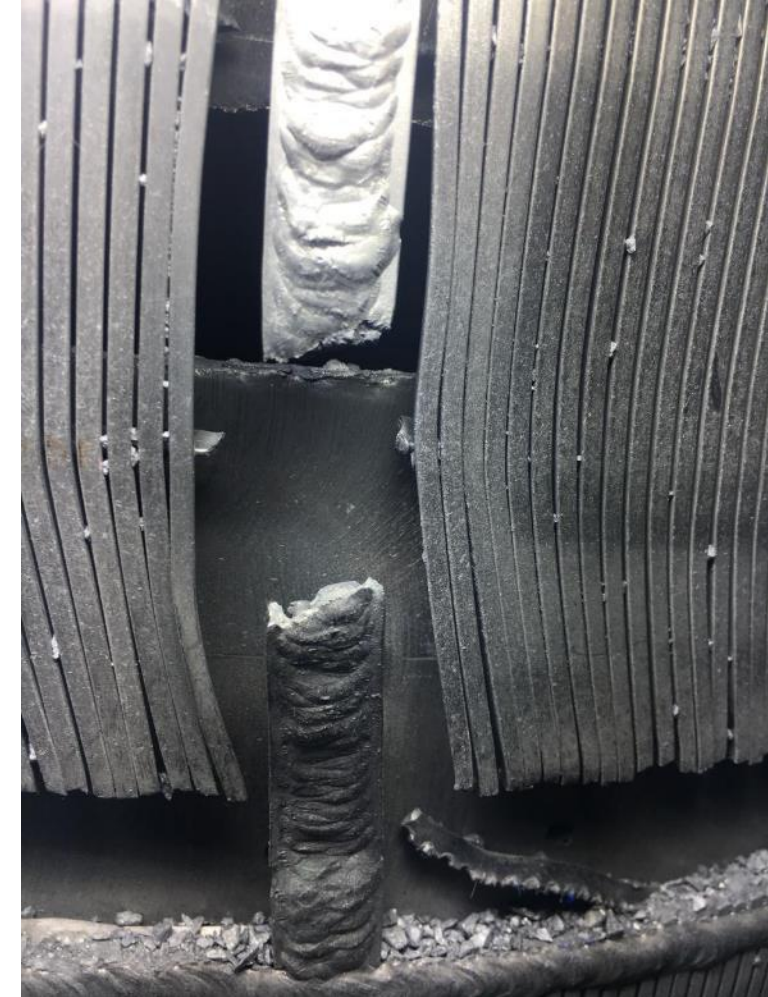
- The basket has been subjected to an extensive number of shutdowns and startups. Every time the center screen is exposed to a thermal and mechanical stress. When this stress is applied repeatedly, then small, localized structural damages will occur in the material and the material will progressively weaken due to fatigue. The nominal maximum stress that can cause a rupture on weakened material are much less than the tensile and yield strength of the material. Thereby microscopic cracks will begin to form at the stress concentrators such as near weldings.
- Eventually a crack will reach a critical size, the crack will propagate suddenly, and the structure will fracture.
